Safety Inspection Report

Annual Inspection

Park Road

Manea Parish Council

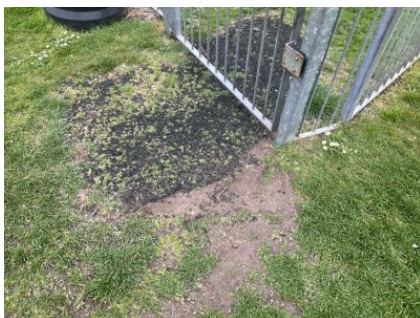
Description	Tasks	Risk score
Ground erosion present.	Repair the worn areas.

Repair the worn areas.

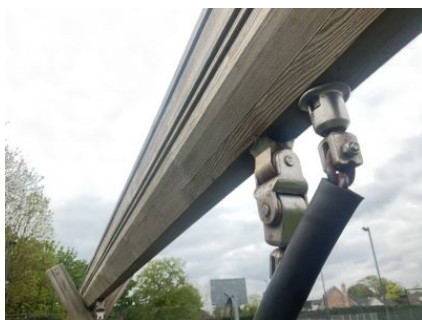
Fixtures loose or missing.

Swing hangers are loose to the top bar. Secure fittings.

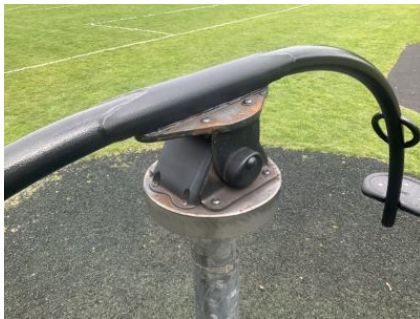
The top section is loose to the post, excess movement and worn bearings. Dismantle and Secure / replace affected fittings.

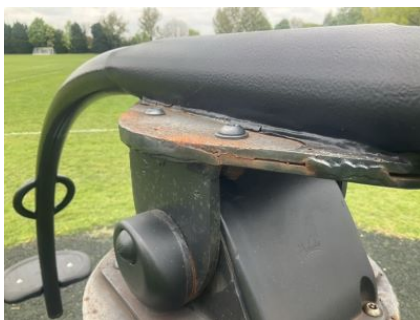
Welds are cracked.

Repair.

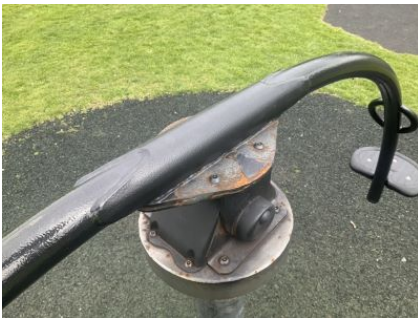
There is significant corrosion on this item.

De-scale back to good metal and coat with lead free paint, using appropriate precautions. Repairs may be necessary where corrosion is severe.

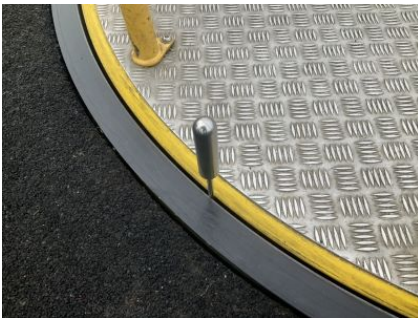
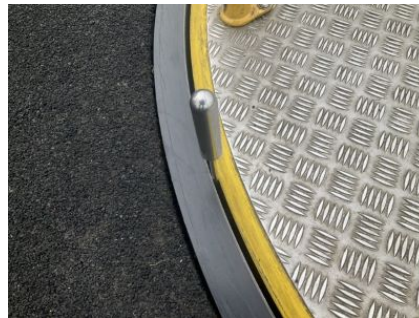
Shrinkage / separation of the surface. This may give a trip hazard.

Edges are shrinking and lifting creating trip points/ ankle turns. Repair.

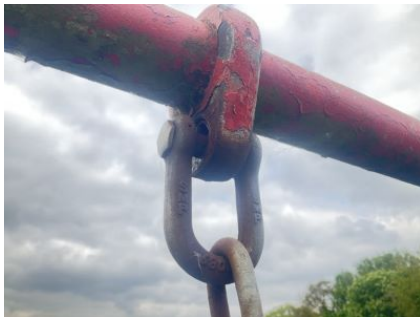
There is wear in the bushes.

Remove shackle bolt and check bush and shackle pin wear, replacing as necessary.

Replace all shackle bushes and check shackle bolts for wear.

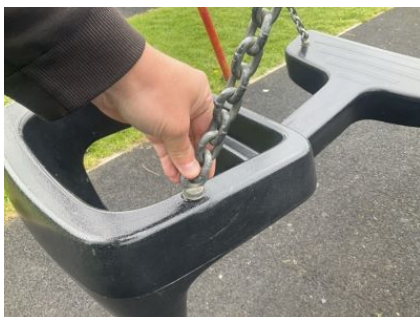
Loose swing seat eye-bolts.

Eye bolts loose on tango seat.

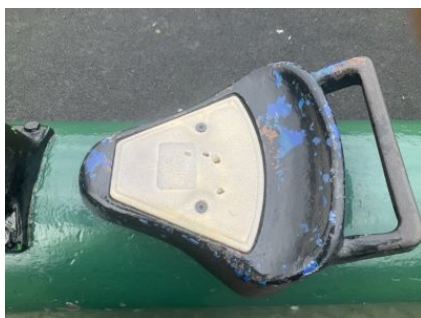
Front seat damaged.

Replace.

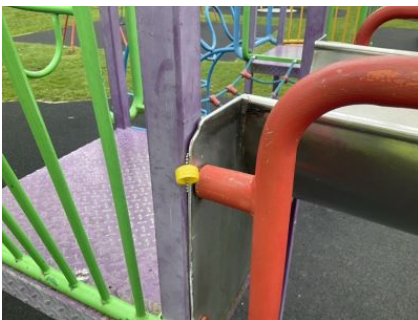
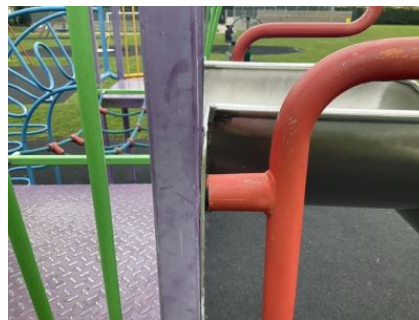
The supports are loose in the ground.

Slide bottom support posts are loose in the ground.

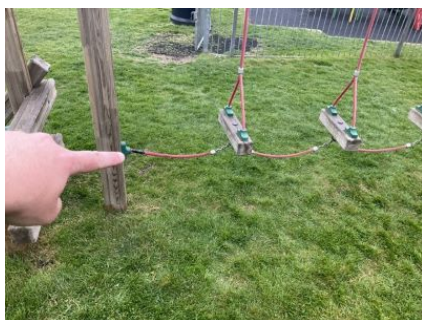
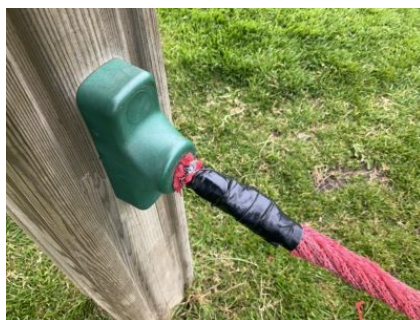
Description	Tasks	Risk score
Exposed metal rope core(s) with sharp points.	Replace.

Replace.

Replace damaged rope section.

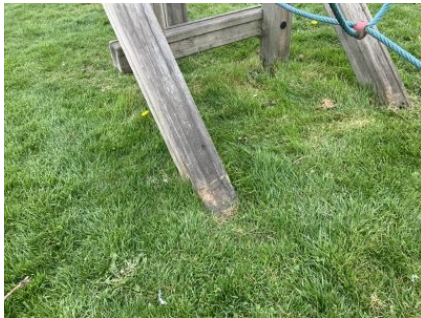
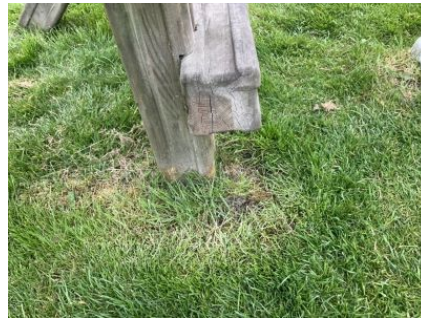
Strimmer damage is present on posts, allowing water to enter and timbers to soften. It can also remove the protective envelope around the timber. Prevent further damage and check timbers for decay throughout the year.

Prevent further damage.

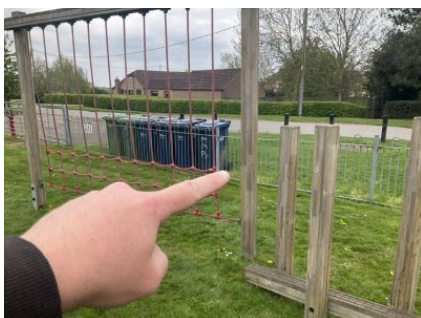
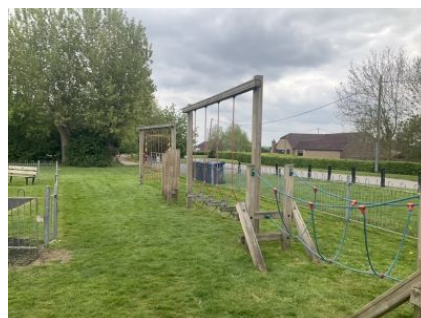
This equipment relies on one post for its stability. Special attention should be paid to maintenance (e.g. by monitoring degradation) and if necessary decommissioning the item before the end of its operating life. This is a requirement of the British Standard.

Highlighted single post provided excess movement. Reset if necessary.

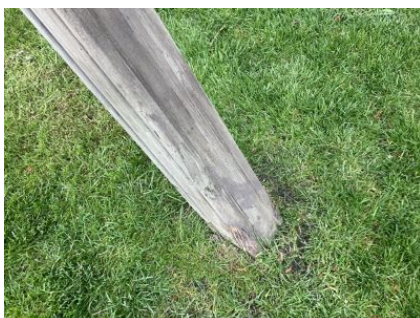
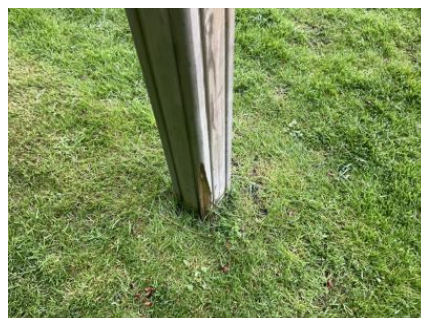
Multiple end supports are damaged, possibly by the gang mower.

Repair.

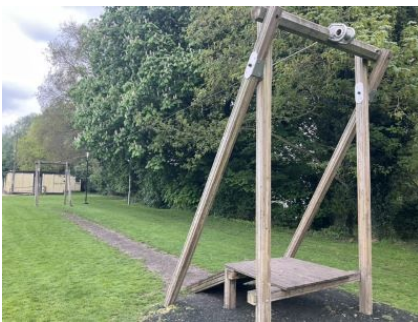
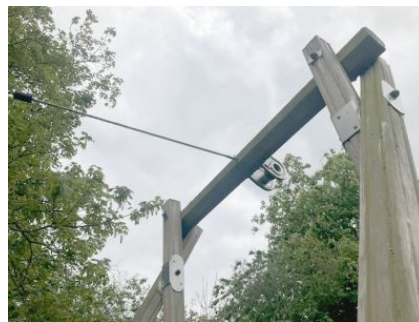
Cables have been known to fail under load due to wear and corrosion. This is generally where the cable enters into a tube, top bar, sleeve or similar, where the wire is in contact and wears and frays over time, but can happen anywhere on the cable. It is important to inspect any hidden parts at least annually. Damaged cables require replacement. This cannot be determined during an annual inspection, and is excluded from our inspection. This can lead to a high risk if no action is taken. Refer to the manufacturer's instructions to ensure the correct check is carried out.

Conduct an appropriate dismantling inspection according to the manufacturer's instructions, and at least annually. The trolley mechanism can be checked at the same time.

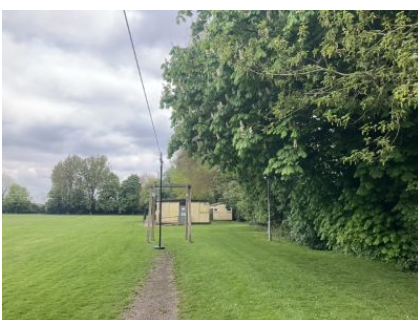
7
Overhanging tree branches are present.	Cut back.

Cut back.

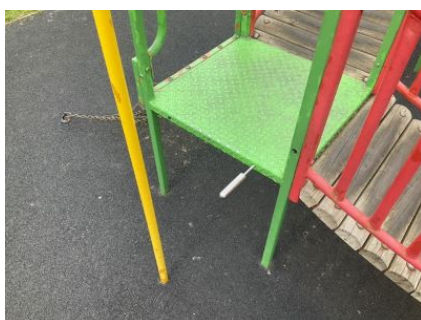
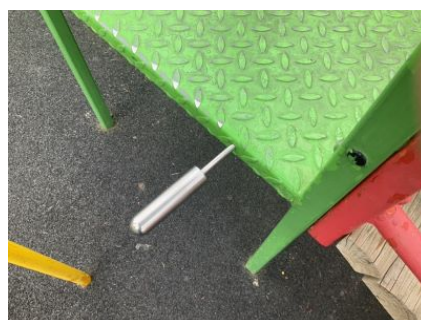
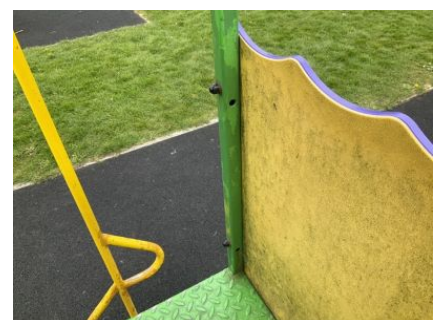
Cap missing.

Replace.

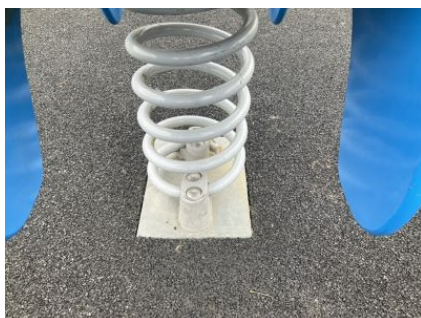
Bolt(s) loose.

Spring plate U-bolts are loosening.
