# Safety Inspection Report

Annual Inspection

## Skate Park

25 April 2025

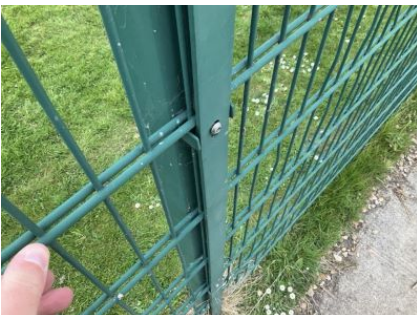
Bolt(s) loose.

Several panel bolts loose and projecting.

Tighten.

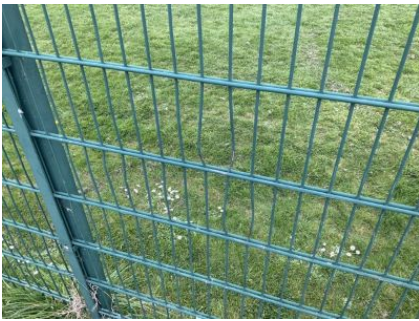
Item is bent.

4

Repair.

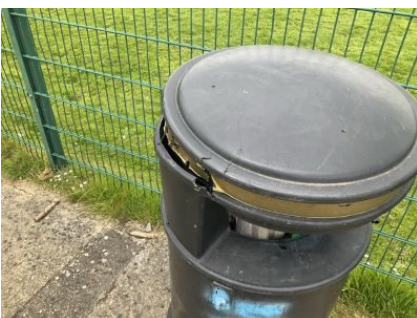
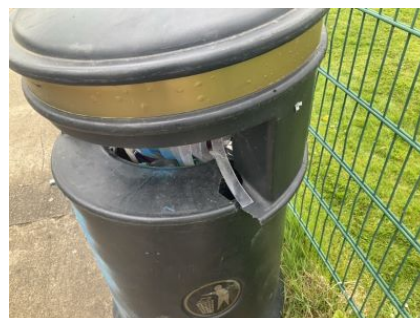
Item is damaged.

**Risk score:** 8

Replace.

Replace plastic bin.

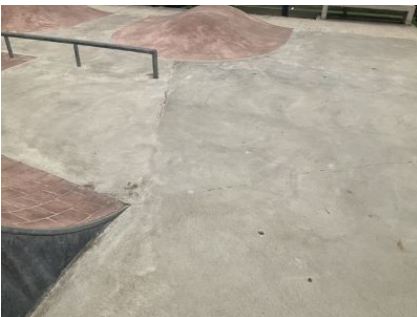
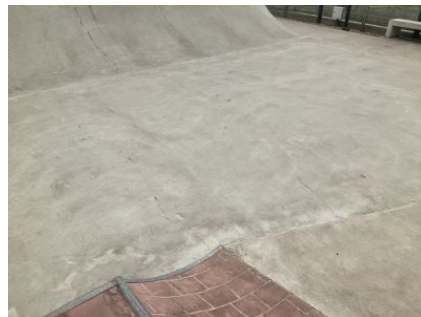
The surface is cracking.

**Risk score:** 7

Repair.

Small section cracking repair and monitor all repaired sections.

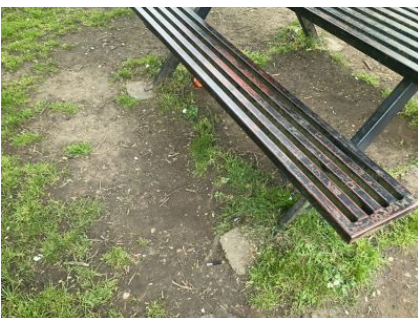
Ground erosion present.

**Risk score:**  
6

Repair the worn areas.

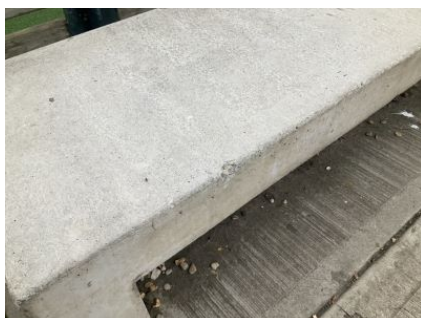
Concrete edges are in poor condition.

5

Monitor edges.

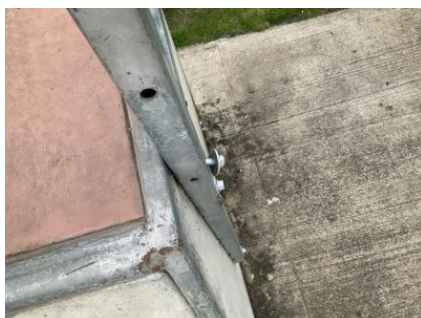
Fixtures loose or missing.

Barrier bolts.

8

Tighten.

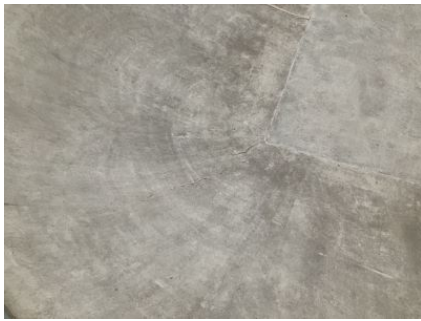
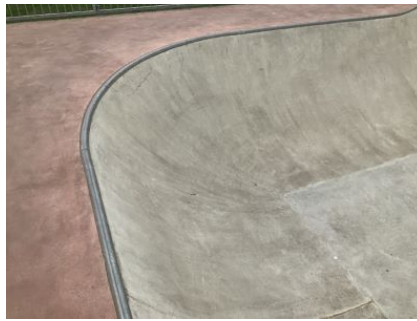
The surface is cracking.

6

Repair.

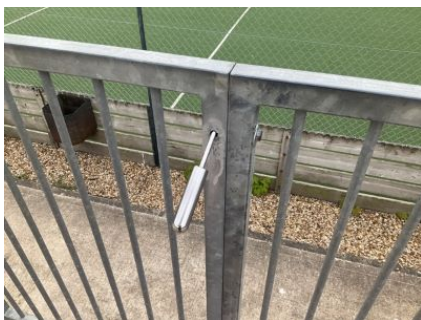
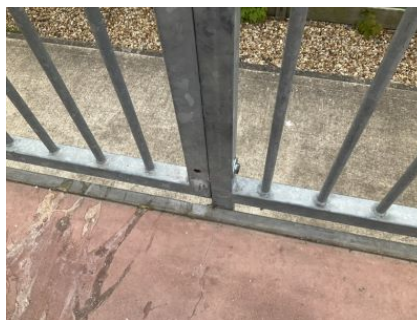
Cap missing.

Barrier fixing holes.

5

Replace.

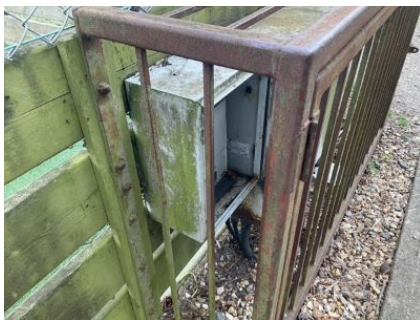
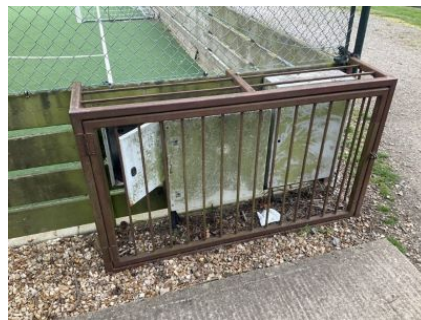
Electric box was left open at the time of inspection. Ensure all boxes are locked, as access to the wires is possible.

No electrical testing has been carried out.

12

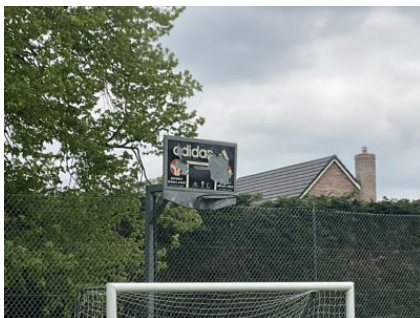
Item is damaged.

Blackboard damaged, sections may fall onto a user below. Replace / remove backboard plastic.

8

Repair., Replace.

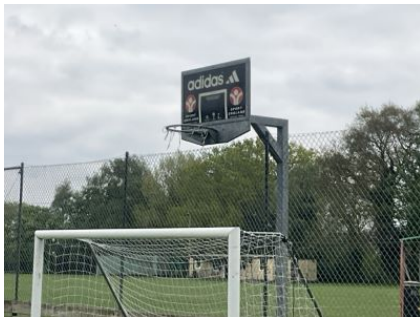
The netting is damaged.

6

Remove remaining parts of netting.

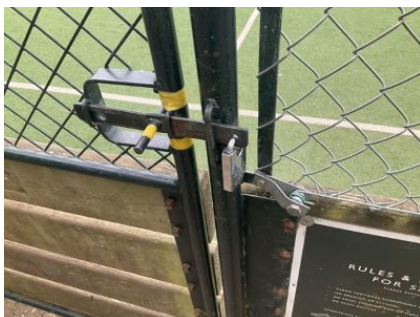
Site was locked at the time of inspection.

The MUGA gates were locked. However, the perimeter was inspected.
