# Safety Inspection Report

Annual Inspection

## Park Road

Manea Parish Council

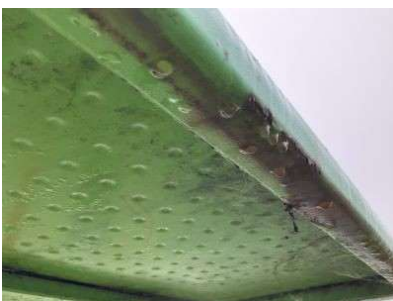
corrosion.

Item has

The frame seam is splitting open. This may be due to water ingress.

Read the notes for further action., Treat and repair.

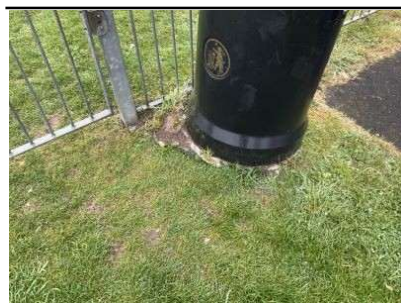
supports are loose in the ground.

Toddler bin loose in the ground exposing the foundations.

Re-set.

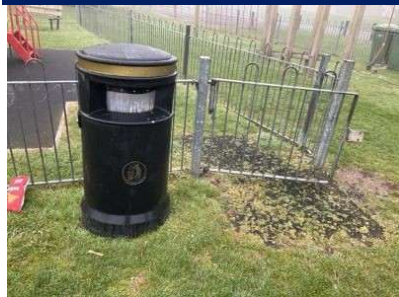
RoSPA recommends that litter bins should not be closer than 2 m from seats and gates (max of 3 m recommended). If they are too far away they may not be used. If they are too

cause nuisance from wasps.

Due to wasps and bees.

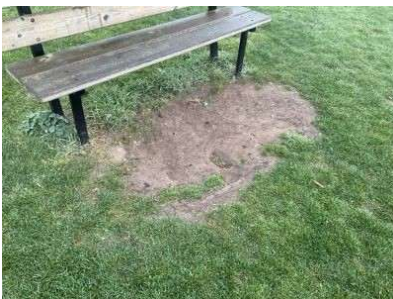
Ground erosion present.

In front of the toddler seat.

Repair the worn

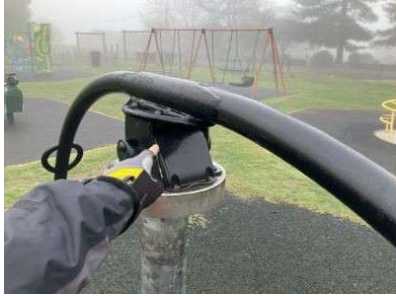
The top section is loose to the post, excess movement and worn bearings.  
Dismantle and secure/replace affected fittings.

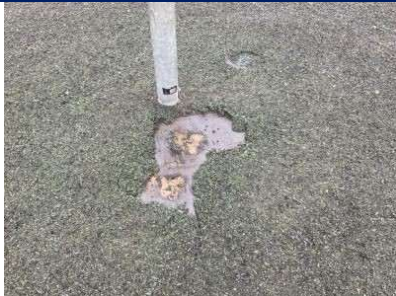
Surface needs repair.

Large holes the surface exposing the sub base below.

Repair.

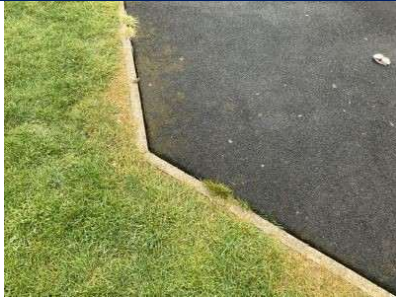
Shrinkage / separation of the surface. This may give a trip hazard.

are shrinking and lifting creating trip points/ankle turns. Repair.

Edges

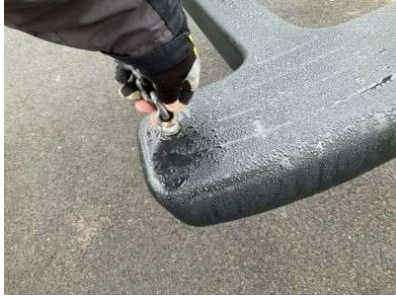
Loose swing seat eye-bolts.

bolts loose on tango seat.

Eye

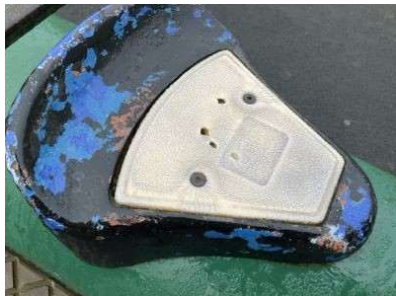
Vandalised.

seat damaged.

Replace.

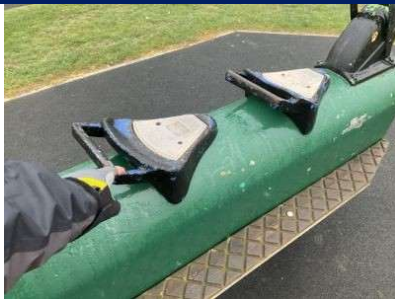
Bolt(s) loose.

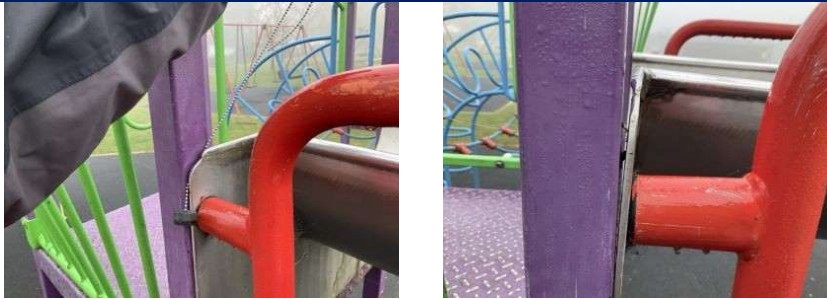
Slide top fixing plate is pulling away from the post, creating a potential toggle entrapment.

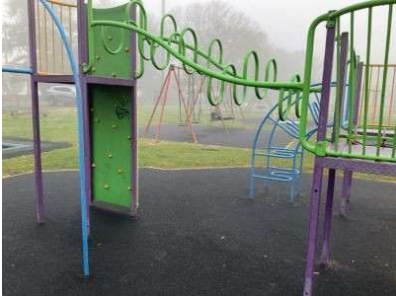
Overhead ladders and rings provide significant play value and benefits to children, and with it the risk of falling. Ensuring the surface remains in good condition will help to keep the correct balance between benefits and risk.

The protective surface under all bars and rings must be kept in good condition.

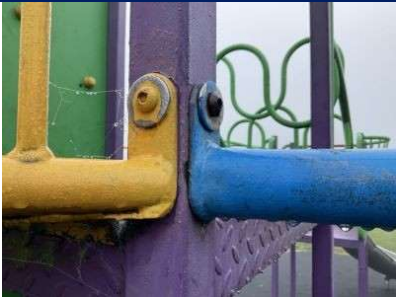
Bolt(s) loose.

Descending pole bolts and barrier bolts around bridge.

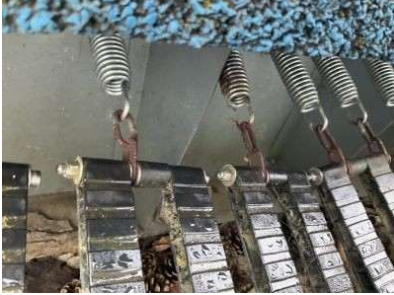
Fittings are rusty.

Chain links rusting. Monitor.

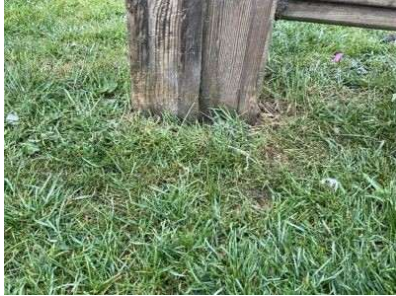
Strimmer damage is present on posts, allowing water to enter and timbers to soften. It can also remove the protective envelope around the timber. Prevent further damage and check timbers for decay throughout the year.

Prevent further damage.

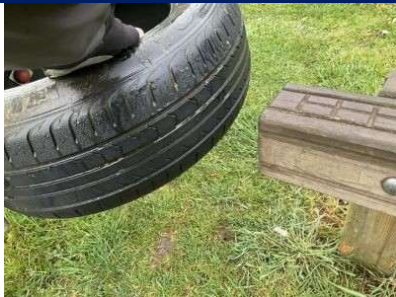
There is excess movement to the tyre walk to the front and rear of the unit.  
Consult the manufacturer for their comments.

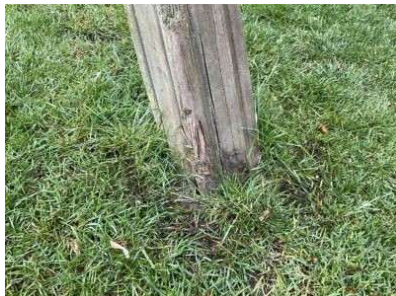
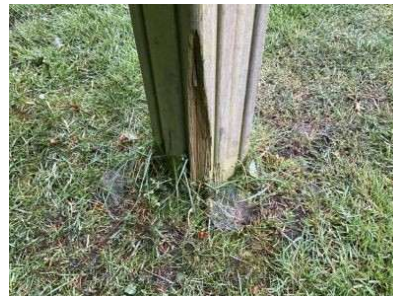
Timber is smashed.

Multiple end supports are damaged, possibly by the gang mower.

Repair.

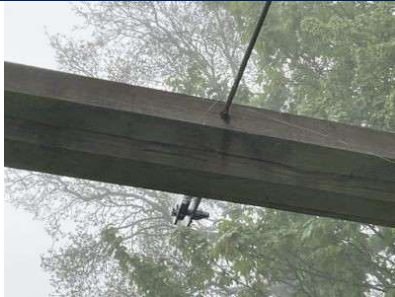
Cables have been known to fail under load due to wear and corrosion. This is generally where the cable enters into a tube, top bar, sleeve or similar, where the wire is in contact and wears and frays over time, but can happen anywhere on the cable. It is important to inspect any hidden parts at least annually. Damaged cables require replacement. This cannot be determined during an annual inspection, and is excluded from our inspection. This can lead to a high risk if no action is taken. Refer to the manufacturer's instructions to ensure the correct check is carried out.

Conduct an appropriate dismantling inspection according to the manufacturer's instructions, and at least annually. The trolley mechanism can be checked at the same time.

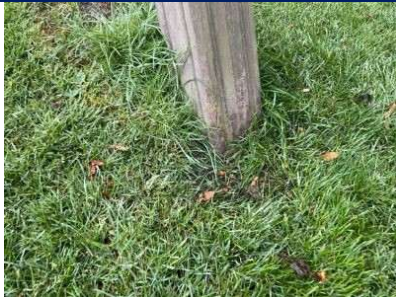
Strimmer damage is present on posts, allowing water to enter and timbers to soften. It can also remove the protective envelope around the timber. Prevent further damage and check timbers for decay throughout the year.

Prevent further damage.

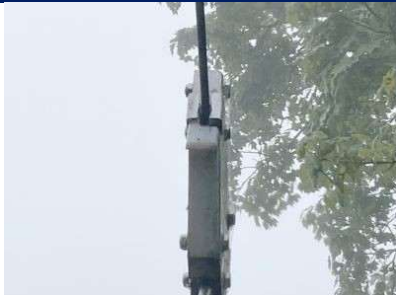
Item is worn.

Finger guards nearly worn through on traveller.

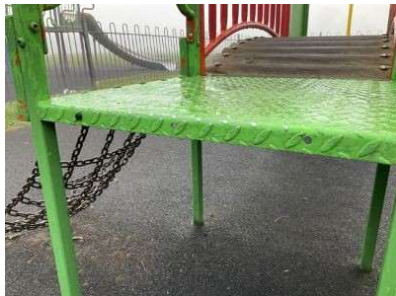
Cap missing.

Deck plugs missing.

Replace.
