Safety Inspection Report

Annual Inspection

Skate Park

Manea Parish Council

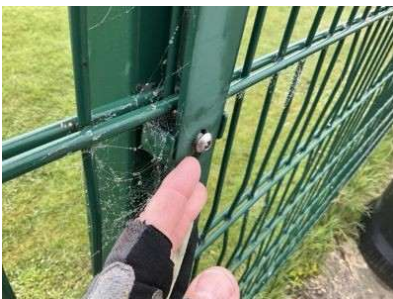
Fencing (Field Side Only)

Bolt(s) loose.

Several panel bolts loose and projecting.

Tighten.

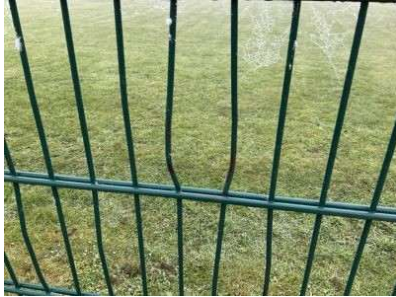
Item is bent.

Repair.

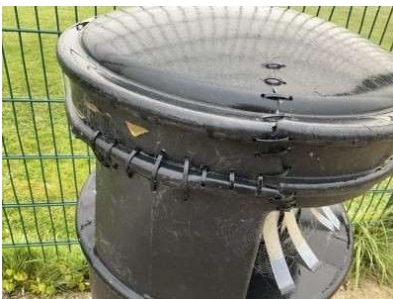
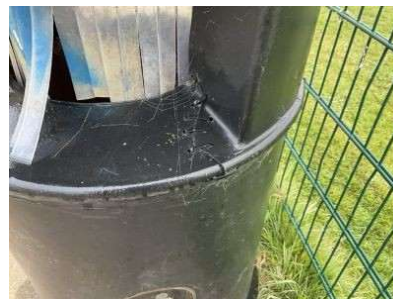
Litter Bin

Item is damaged.

Litter bin has been repaired. Monitor repairs.

Read the notes for further action.

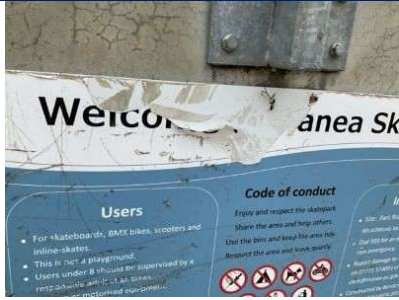
Signage - Skate

Item is damaged.

Repair.

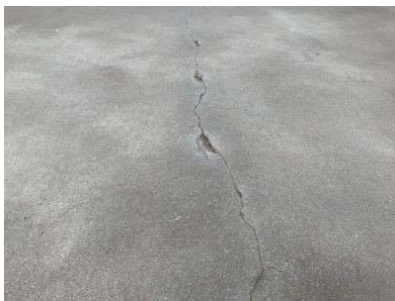
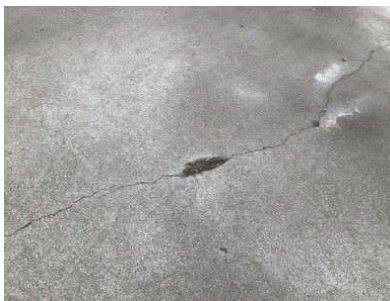
General Surface - Concrete

The surface is cracking.

Small section cracking repair and monitor all repaired sections.

Repair.

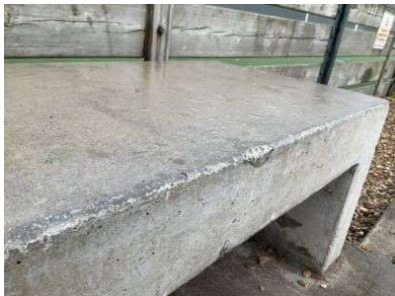
Wheeled Sport - Grind Benches x 2

Concrete edges are in poor condition.

Monitor edges.

Read the notes for further action.

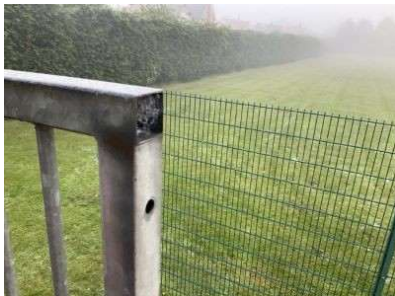
Wheeled Sport - Bowl

Cap missing.

Barrier end cap missing and infill bolt fixing holes.

Replace., Read the notes for further action.

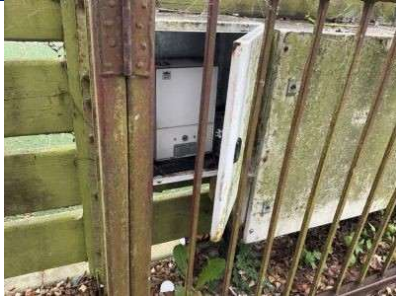
Electric box was left open at the time of inspection. Ensure all boxes are locked, as access to the wires is possible. No electrical testing has been carried out.

Read the notes for further action.

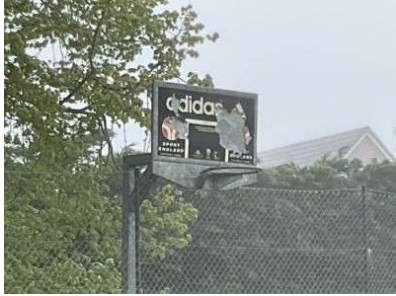
Item is damaged.

Blackboard damaged, sections may fall onto a user below. Replace/remove backboard plastic.

Repair, Replace.

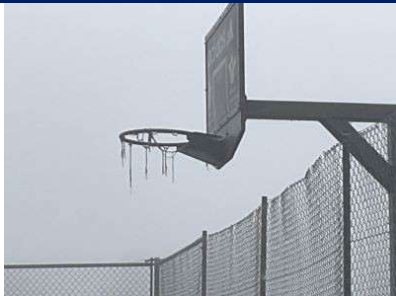
The net is damaged.

Remove remnants of netting from ring.

Remove the net.

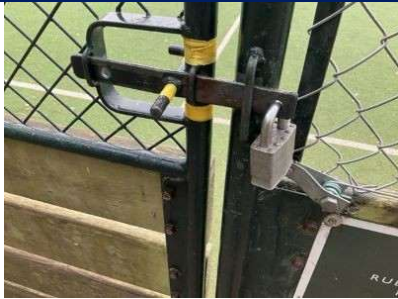
Site was locked at the time of inspection.

The MUGA gates were locked. However, the perimeter was inspected.
