# Safety Inspection Report

Annual Inspection

## Park Road

Site name: **Park Road**  
Date of inspection: **20 April 2020**  
Inspector: **David Owen**

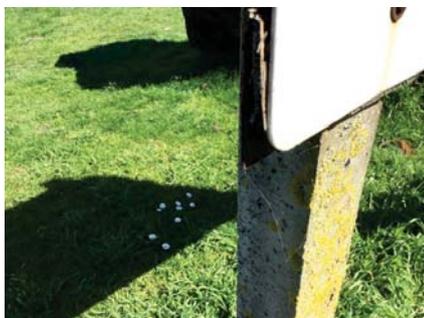
Sharp edges to frame of signage - smooth off.

See the notes.

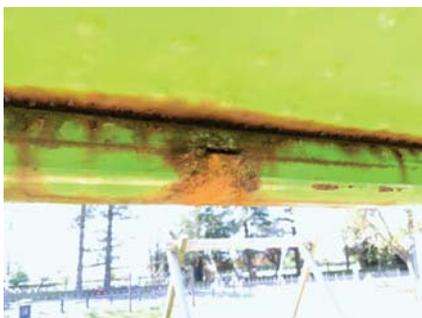
Item has corrosion.

The frame seam is splitting open. This may be due to water ingress.

Read the notes for further action., Treat and repair.

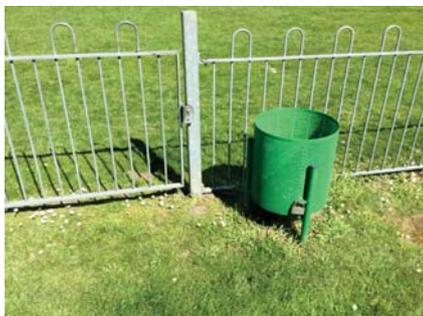
RoSPA recommends that litter bins should not be closer than 2 m from seats and gates (max of 3 m recommended). If they are too far away they may not be used. If they are too close this may cause nuisance from wasps.

Due to wasps and bees.

Move the bin or seat as appropriate.

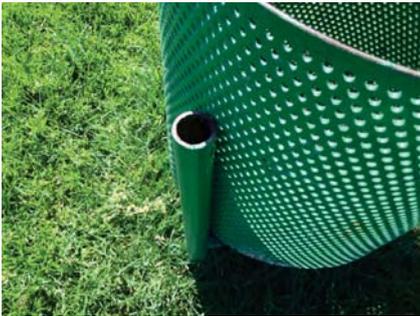
Cap missing.

Frame cap missing.

Replace.

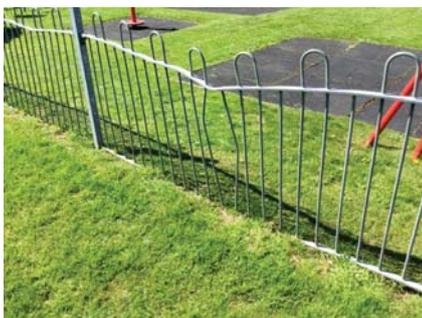
Item is bent.

Repair.

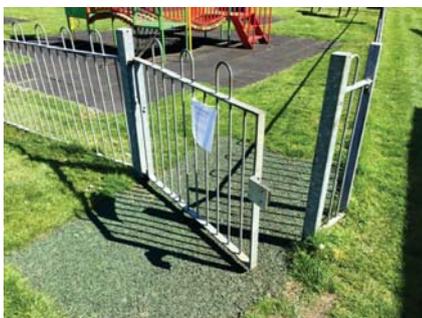
Mechanism needs adjustment.

Gate does not fully self close.

Adjust.

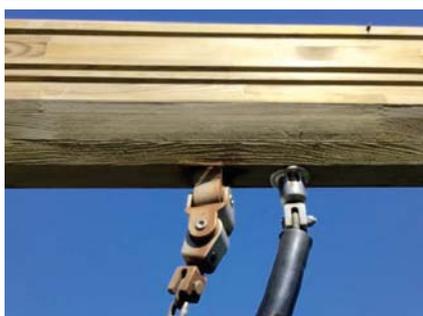
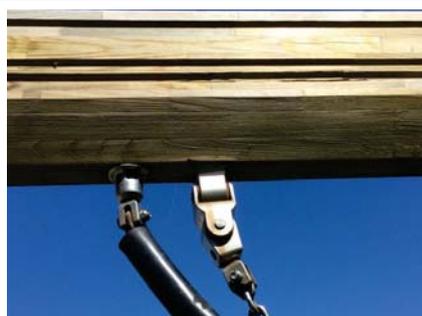
Bolt(s) loose.

Swing hangers loose to top bar. Straighten & tighten. Failure to repair will elongate the bolt holes.

Tighten.

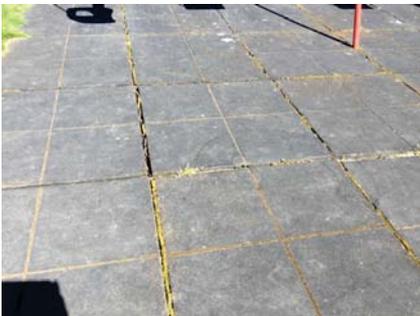
Gaps have opened up between tiles causing trip hazard.

Moss between tiles.

Large gaps within the surface area could turn ankles. Gaps are larger than 30 mm where a foot could enter. This does not BS EN 1176 Part 1 Section 4.2.7.5. - repair surface.

Refit the tiles.

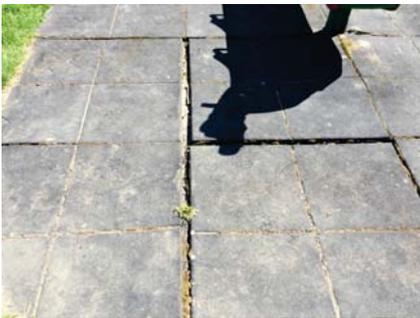
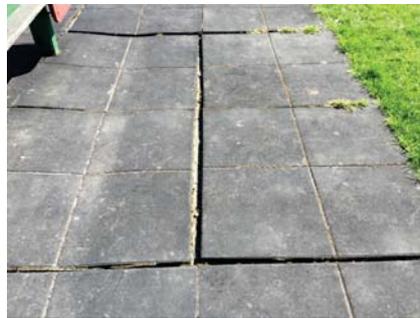
Gaps have opened up between tiles causing trip hazard.

Large gaps within the surface area could turn ankles. Gaps are larger than 30 mm where a foot could enter. This does not comply to BS EN 1176 Part 1 Section 4.2.7.5. - repair surface.

Refit the tiles.

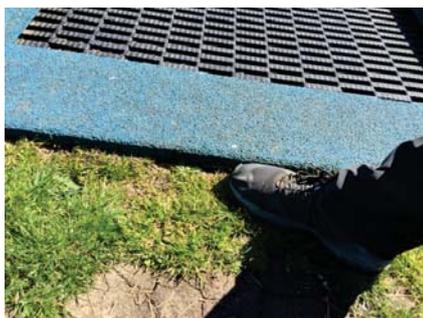
Trip points on the surface.

Reinstate erosion around rubber surround.

Make level.

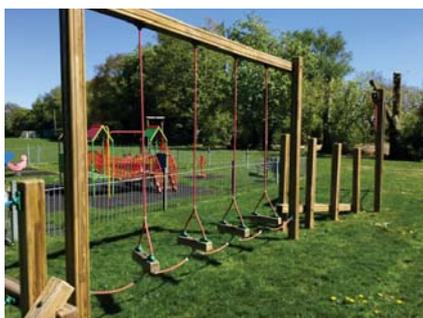
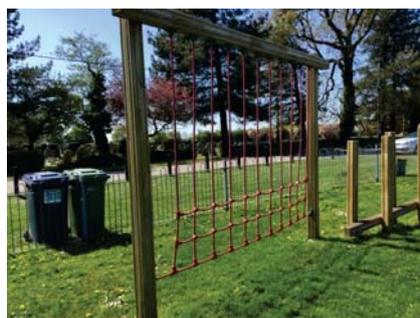
This equipment relies on one post for its stability. Special attention should be paid to maintenance (e.g. by monitoring degradation) and if necessary decommissioning the item before the end of its operating life.

Consult with the manufacturer's guidance to determine suitable maintenance.

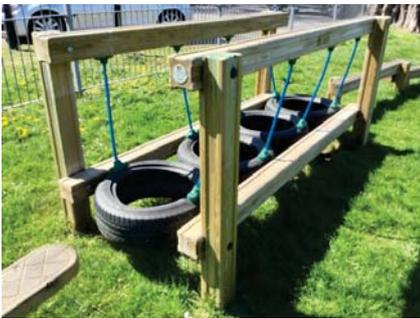
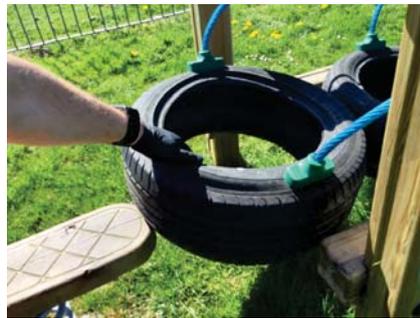
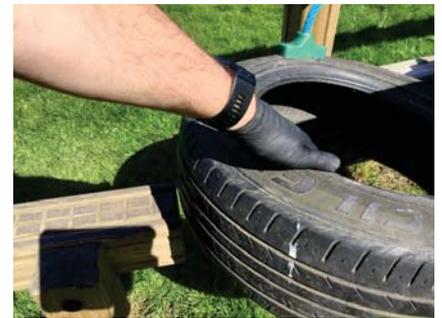
There is excess movement to the tyre walk to the front and rear of the unit - consult the manufacturer for their comments.

Read the notes for further action.

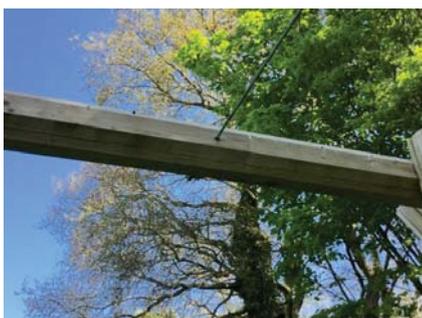
Where the cable enters into a tube, top bar or similar it is not possible to determine its condition, therefore this is excluded from our inspection. It is vital that the operator arranges to dismantle the unit to inspect the full length of the cable for any corrosion, wear or damage.

Conduct an appropriate dismantling inspection.

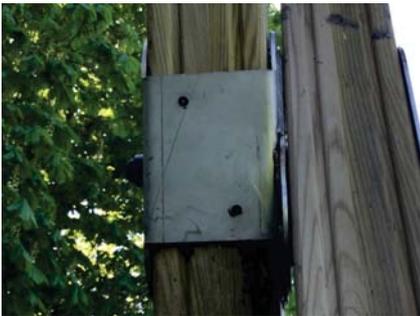
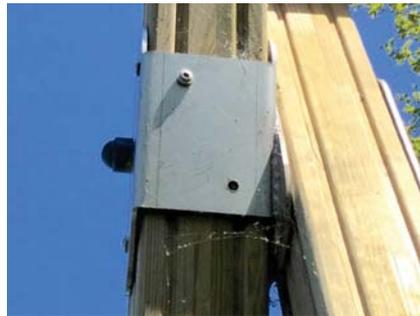
Fixtures loose or missing.

Three screws damaged / missing from the section support brackets.

Replace.

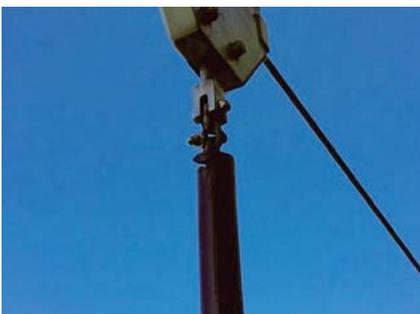
Item is damaged.

The chain rubber sleeve is damaged at the top. The rubber will start to slip down the chain - install new bolt approximately 5" from the top to prevent ripping through the rubber.

Repair.

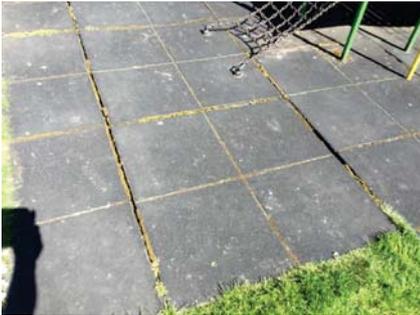
Gaps have opened up between tiles causing trip hazard.

Refit the tiles.

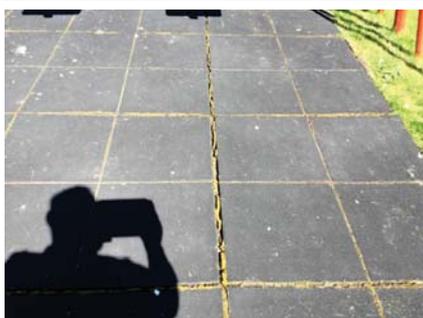
Gaps have opened up between tiles causing trip hazard.

Large gaps could turn ankles - repair surface, re-lay mats.

Refit the tiles.

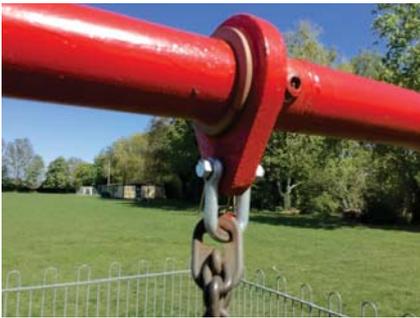
Moving parts require greasing.

Bearings squealing.

Apply lubricant according to the manufacturer's instructions.

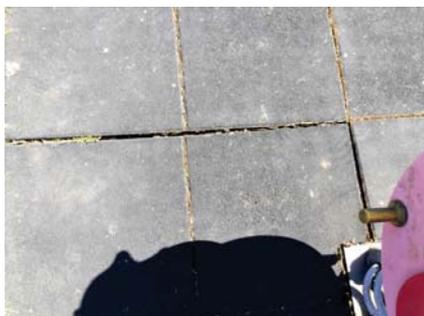
The item or its surfacing are not compliant with the requirements of the relevant standards.

Gaps have opened up between tiles causing trip hazard.

Re-glue and fill gaps and joints as necessary.

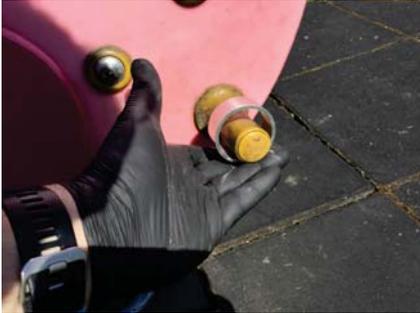
Protruding handles / foot rests.

No reasonably practicable action is identified.
