# **Safety Inspection Report**

**Annual Inspection**

# **Park Road**

# Manea Parish Council

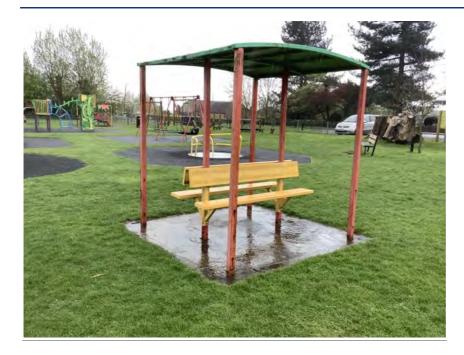
# **Youth Shelter**

Item has corrosion.

The frame seam is splitting open. This may be due to water ingress.

Read the notes for further action., Treat and repair.

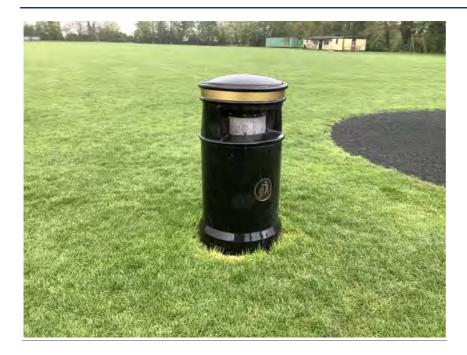
# **Litter Bins**

RoSPA recommends that litter bins should not be closer than 2 m from seats and gates (max of 3 m recommended). If they are too far away they may not be used. If they are too close this may cause nuisance from wasps.

Due to wasps and bees.

Move the bin or seat as appropriate.

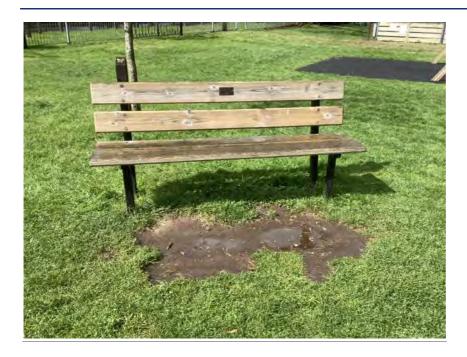
# **Seating - Various**

Ground erosion present.

In front of the toddler seat.

Repair the worn areas.

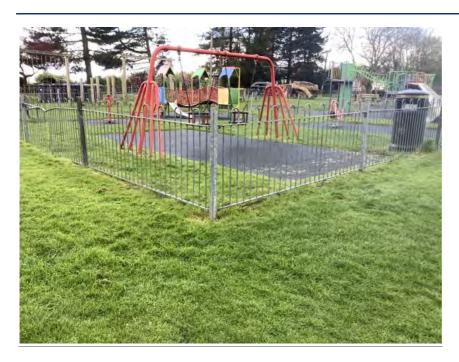
# Fencing (Toddler Area Only)

Item is bent.

Repair.

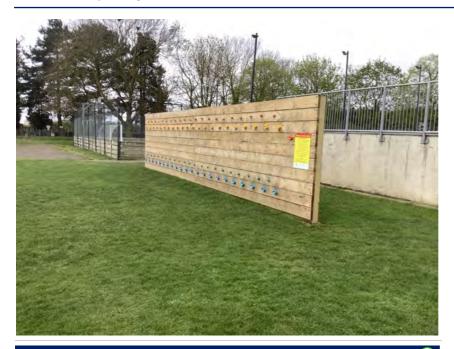
# **Climber - Traverse Wall**

There are finger entrapments between the boards. Monitor.

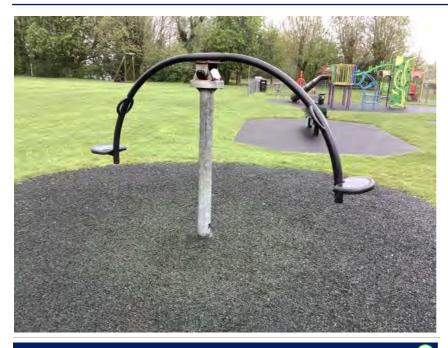
# **Rocker - Sweeping Seesaw - Gyro Spiral**

Fixtures loose or missing.

The top section is loose to the post, excess movement. Secure all fittings.

There is significant corrosion on this item.

Read the notes for further action., Tighten.

De-scale back to good metal and coat with lead free paint, using appropriate precautions. Repairs may be necessary where corrosion is severe.

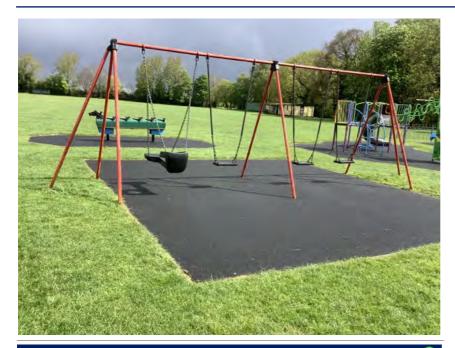
# Swing - Mixed - 2 Bay 3 Junior with Anti-Wrap 1 Tango Seat (2400 mm)

There is wear in the bushes.

Loose swing seat eye-bolts.

Eye bolts loose on tango seat.

Remove shackle bolt and check bush and shackle pin wear, replacing as necessary.

Replace all shackle bushes and check shackle bolts for wear.

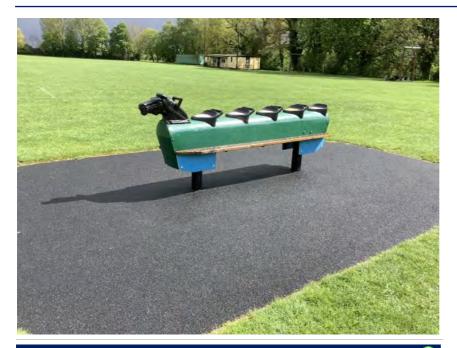
# **Rocker - Rocking Horse**

Vandalised.

Front seat damaged.

Replace.

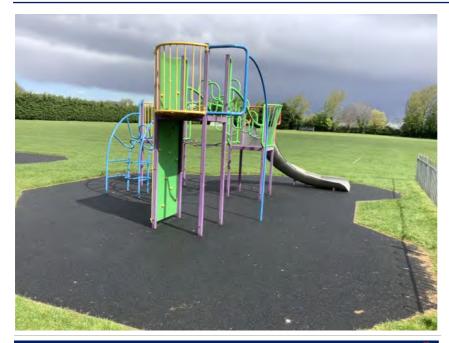
# **Multiplay**

The item is not compliant with the requirements of the relevant standards. The surfacing meets with the requirements of the relevant standards.

The supports are loose in the ground.

Slide bottom support posts are loose in the ground.

There is a toggle entrapment.

Slide top fixing plate is pulling away from the post creating a potential toggle entrapment.

Eliminate the entrapment.

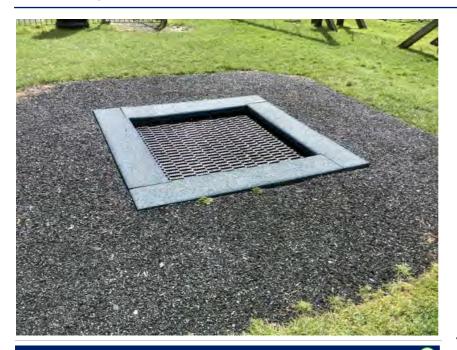
# **Agility - Trampoline - Play**

Trip points on the surface.

Eco mulch has started to settle creating potential trip points around the tile edges.

Make level.

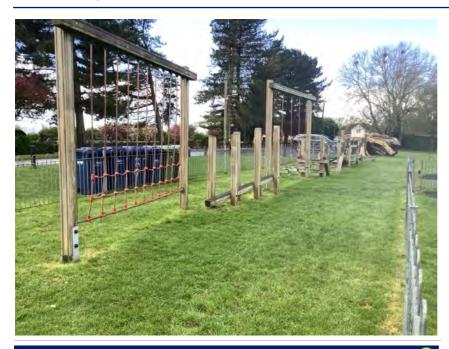
# **Agility - Trim Trail**

There is excess movement to the tyre walk to the front and rear of the unit. Consult the manufacturer for their comments.

Strimmer damage is present on posts, allowing water to enter and timbers to soften. It can also remove the protective envelope around the timber. Prevent further damage and check timbers for decay throughout the year.

Prevent further damage.

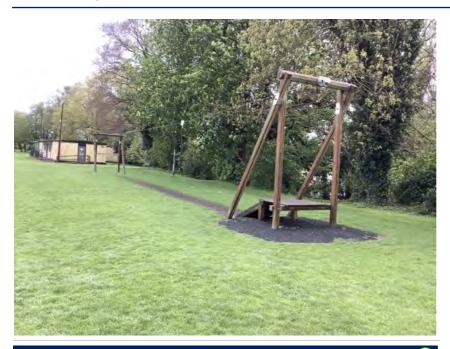
# **Cableway**

Chain covers prevent a thorough inspection of all chain links.

Cables have been known to fail under load due to wear and corrosion. This is generally where the cable enters into a tube, top bar, sleeve or similar, where the wire is in contact and wears and frays over time, but can happen anywhere on the cable. It is important to inspect any hidden parts at least annually. Damaged cables require replacement. This cannot be determined during an annual inspection, and is excluded from our inspection. This can lead to a high risk if no action is taken. Refer to the manufacturer's instructions to ensure the correct check is carried out.

Strimmer damage is present on posts, allowing water to enter and timbers to soften. It can also remove the protective envelope around the timber. Prevent further damage and check timbers for decay throughout the year.

Timber is smashed.

End angle post damaged, possibly by the gang mower.

Remove chain covers to inspect according to manufacturer's instructions, and replace the covers when done.

Conduct an appropriate dismantling inspection.

Prevent further damage.

Repair.

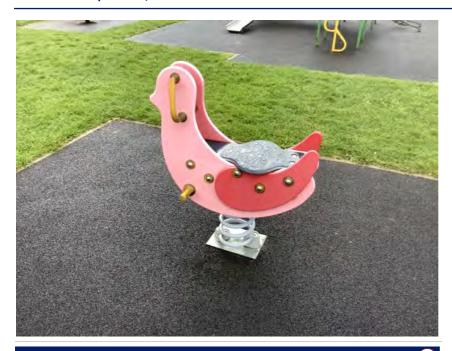
# **Rocker - Bird**

The item is not compliant with the requirements of the relevant standards. The surfacing meets with the requirements of the relevant standards.

Protruding handles / foot rests.

No reasonably practicable action is identified.
