# Safety Inspection Report

Annual Inspection

## Park Road

Site name: **Park Road**  
Date of inspection: **12 April 2023**  
Inspector: **David Owen**

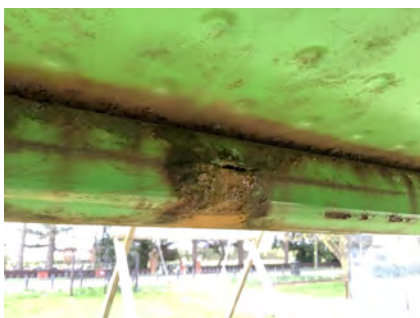
Item has corrosion.

The frame seam is splitting open. This may be due to water ingress.

Read the notes for further action., Treat and repair.

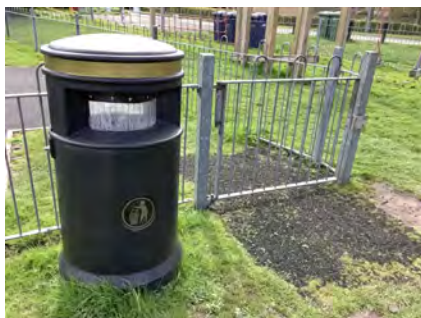
RoSPA recommends that litter bins should not be closer than 2 m from seats and gates (max of 3 m recommended). If they are too far away they may not be used. If they are too close this may cause nuisance from wasps.

Due to wasps and bees.

Move the bin or seat as appropriate.

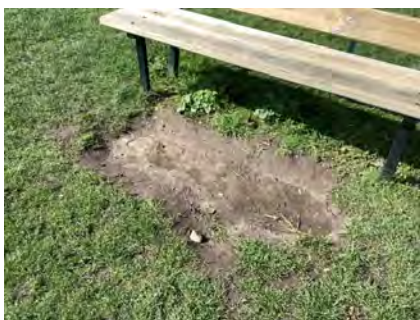
Ground erosion present.

In front of the toddler seat.

Repair the worn areas.

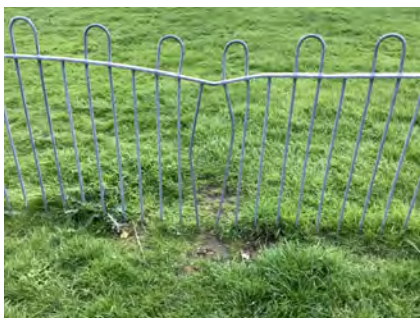
Item is bent.

Repair.

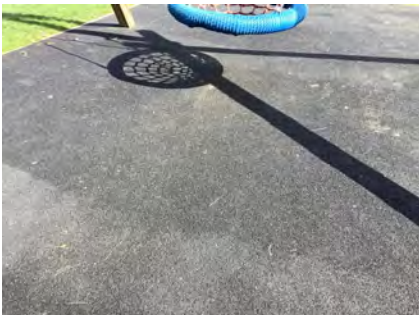
Monitor slight wear to the surfacing.

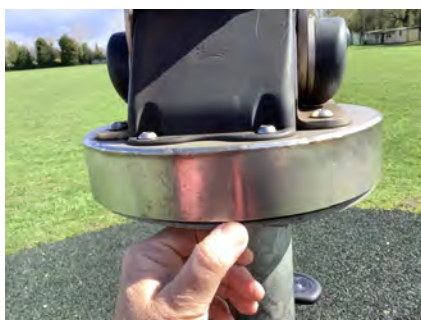
Fixtures loose or missing.

The top section is loose to the post, excess movement.

Read the notes for further action., Tighten.

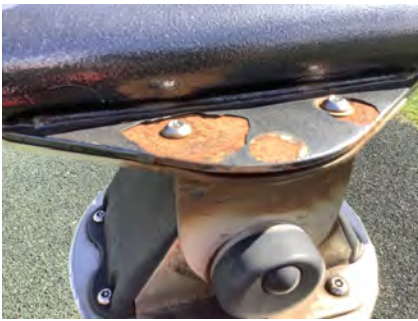
There is significant corrosion on this item.

De-scale back to good metal and coat with lead free paint, using appropriate precautions. Repairs may be necessary where corrosion is severe.

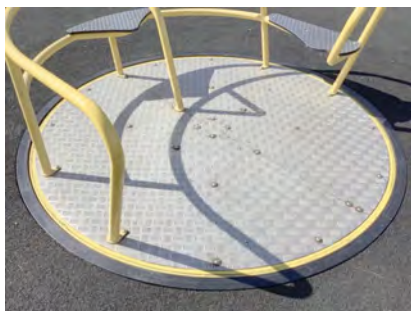
Moving parts require greasing.

Bearings noisy.

Apply lubricant according to the manufacturer's instructions.

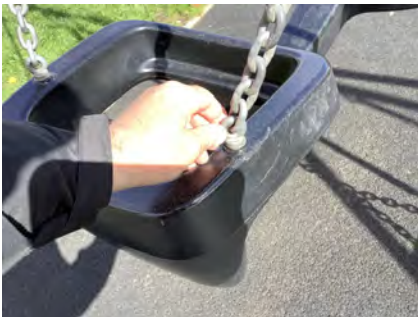
Loose swing seat eye-bolts.

Eye bolts loose on tango seat.

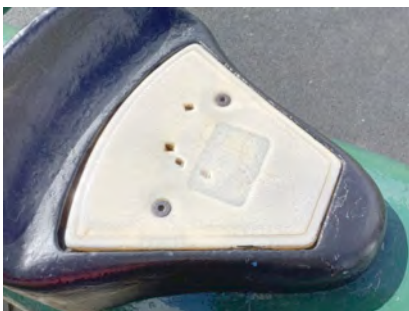
Vandalised.

Front seat damaged.

Replace.

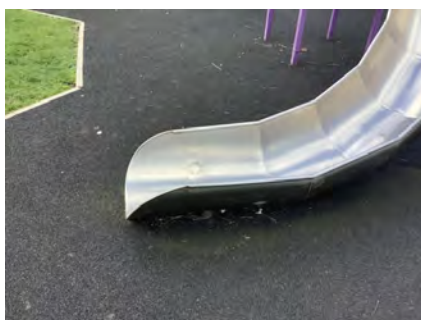
The supports are loose in the ground.

Slide bottom support posts are loose in the ground.

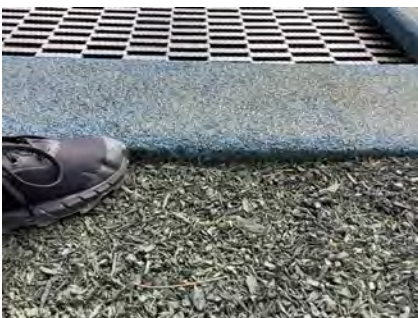
Trip points on the surface.

Eco mulch has started to settle creating potential trip points around the tile edges.

Make level.

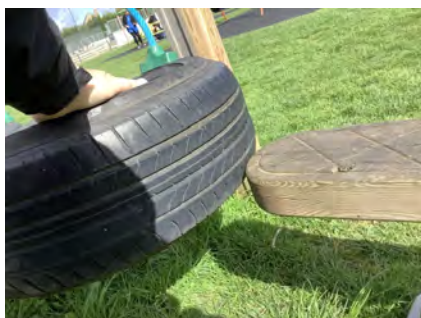
There is excess movement to the tyre walk to the front and rear of the unit. Consult the manufacturer for their comments.

Read the notes for further action.

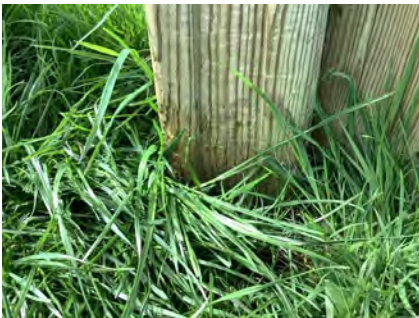
Strimmer damage to supports is likely to accelerate timber rot.

Prevent further damage.

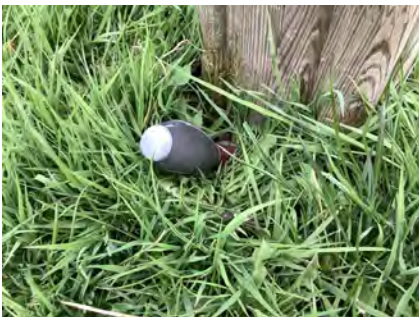
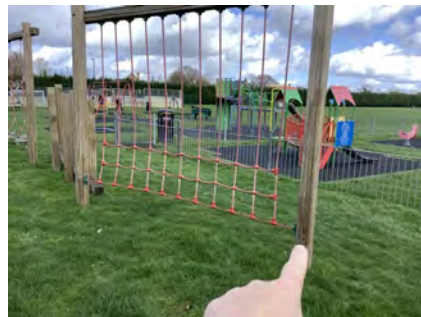
Timber is decayed.

Large net traverse climber has a decayed end post. The post made a cracking sound at ground level while undergoing the whip test. Replace as soon as possible.

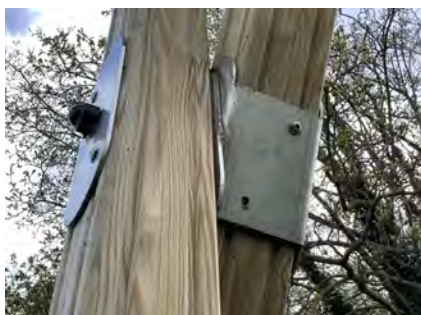
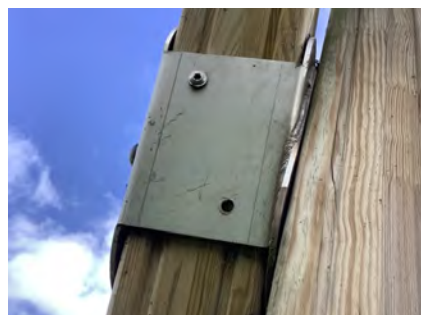
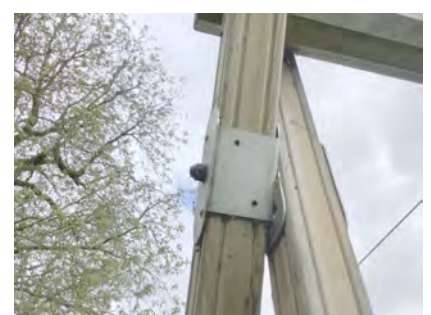
The item is not compliant with the requirements of the relevant standards. The surfacing meets with the requirements of the relevant standards.

Bolt(s) missing.

Bolts missing from the support leg bracket.

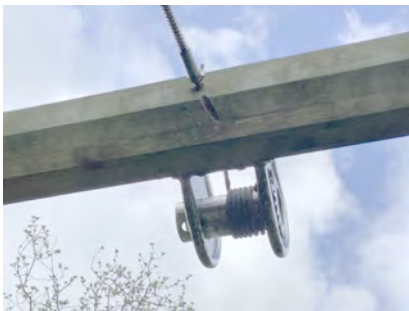
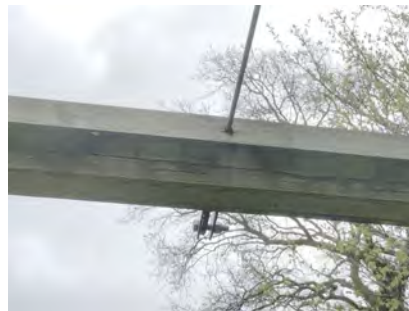
Cables have been known to fail under load due to wear and corrosion. This is generally where the cable enters into a tube, top bar, sleeve or similar, where the wire is in contact and wears and frays over time, but can happen anywhere on the cable. It is important to inspect any hidden parts at least annually. Damaged cables require replacement. This cannot be determined during an annual inspection, and is excluded from our inspection. This can lead to a high risk if no action is taken. Refer to the manufacturer's instructions to ensure the correct check is carried out.

Conduct an appropriate dismantling inspection.

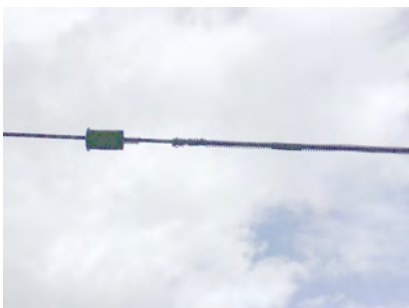
Item broken.

Spring stop broken.

Replace.

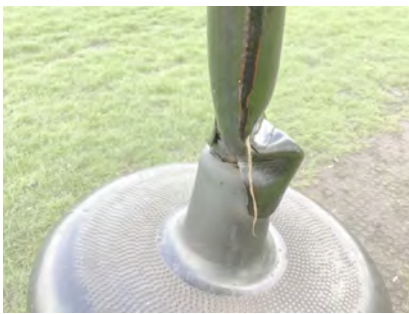
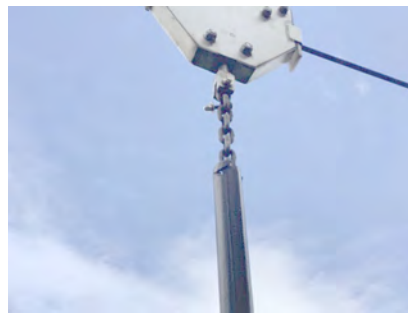
Item is damaged.

The chain rubber sleeve is damaged at the top. The rubber has now slipped down the chain creating a pinch point. Repair and Install new bolt approximately 5" from the top to prevent ripping through the rubber.

Repair.

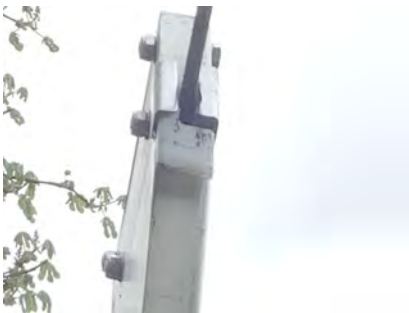
Item is worn.

Traveler plastic cable guard worn.

Replace.

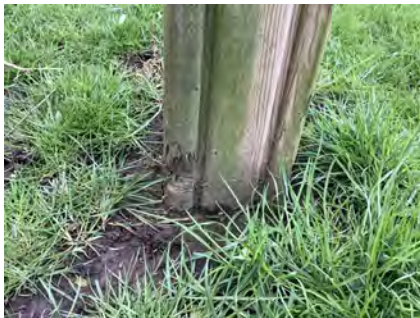
Strimmer damage to supports is likely to accelerate timber rot.

Prevent further damage.

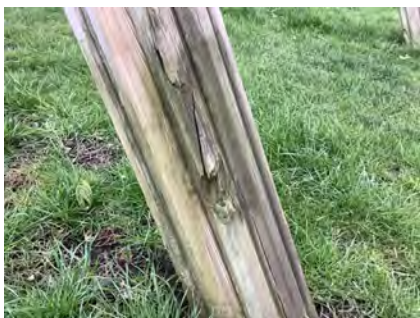
Timber is smashed.

End angle post damaged, possibly by the gang mower.

Repair.

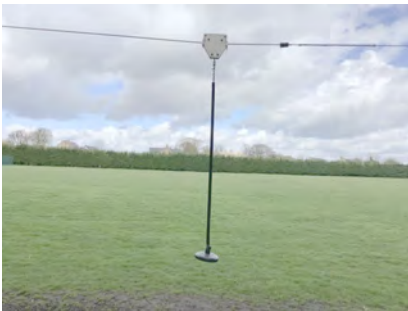
It is considered that the runway will have insufficient ground clearance under seat.

Modify to give a minimum 350 mm clearance under load.

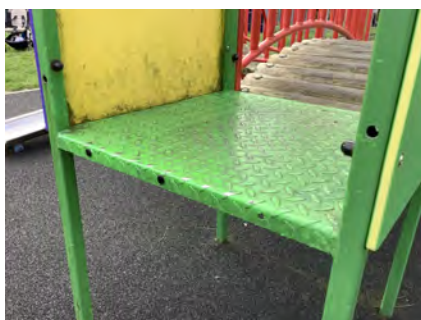
Cap missing.

Frame plugs missing. Replace.

Replace.

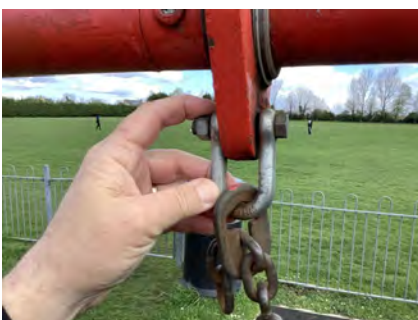
Swing shackles have been over-tightened causing them to jam.

Shackle bolts do not rotate within the bushes x 4.

Apply lubricant according to the manufacturer's instructions.
