Safety Inspection Report

Annual Inspection

Skate Park

Manea Parish Council

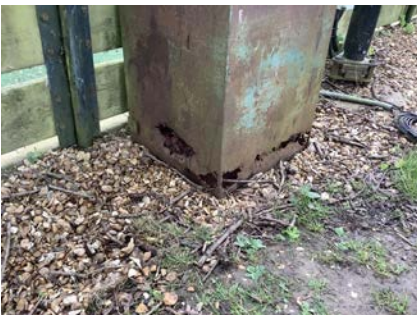
Item has corrosion.

Litter bin adjacent to the MUGA picnic table has corroded through leaving sharp edges. Remove.

Replace.

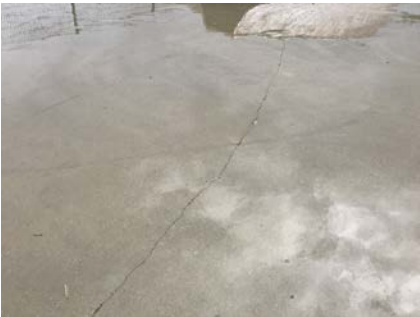
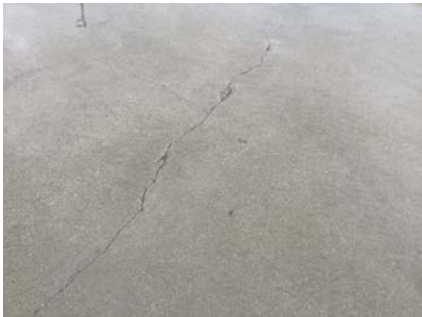
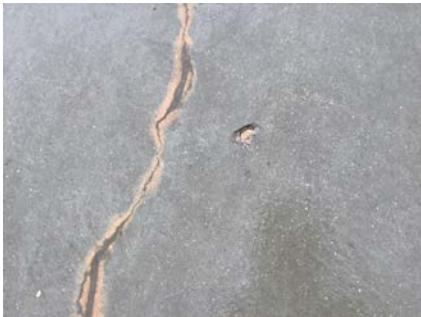
Description
The surface is cracking.
Tasks
Repair.
Note
Small section cracking repair and monitor all repaired sections.

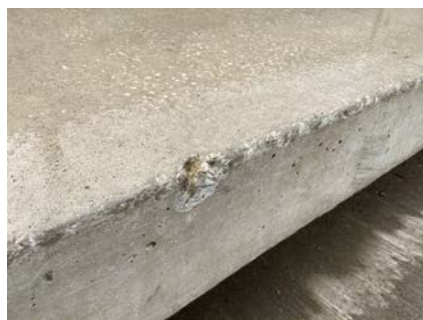
Concrete edges are in poor condition.

Monitor edges.

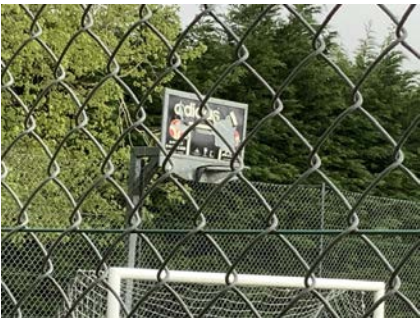
Item is damaged.

Blackboard damaged.

Repair.

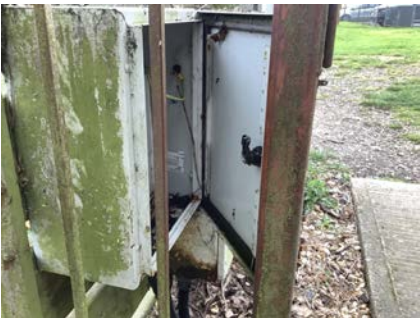
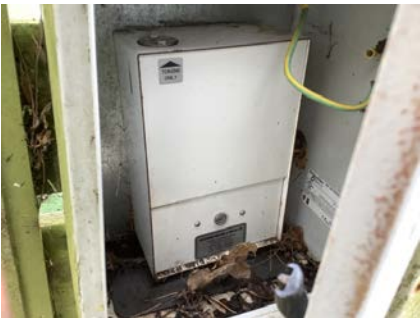
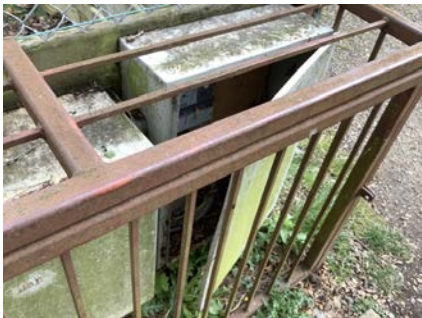
Electric box was left open at the time of inspection. Ensure all boxes are locked as access to the wires is possible.
No electrics have been carried out.

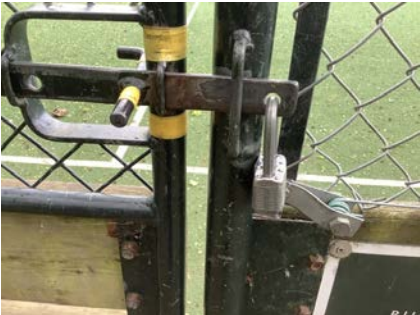
Site was locked at the time of inspection.

The MUGA gates were locked. However, the perimeter was inspected.
