Safety Inspection Report

Annual Inspection

Skate Park

12 April 2023

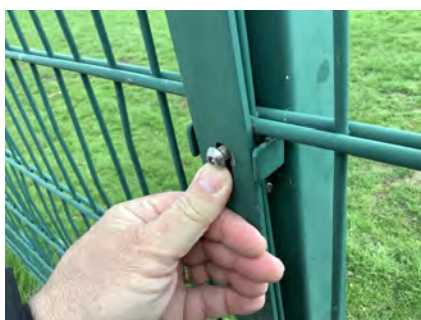
Bolt(s) loose.

Several panel bolts loose.

Tighten.

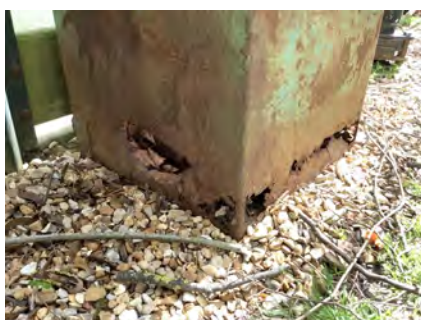
Item has corrosion.

Litter bin adjacent to the MUGA picnic table has corroded through. Remove.

Risk level:
Medium

Risk score:
8

Replace.

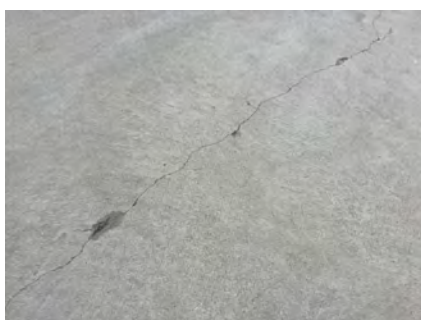
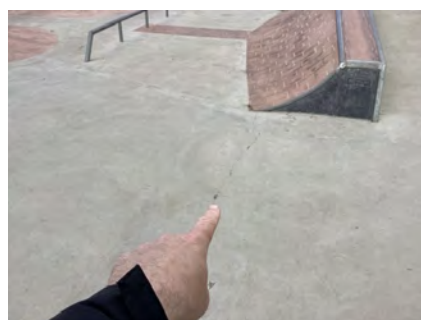
The surface is cracking.

Small section cracking repair and monitor all repaired sections.

Risk level:
Low

Risk score:
6

Repair.

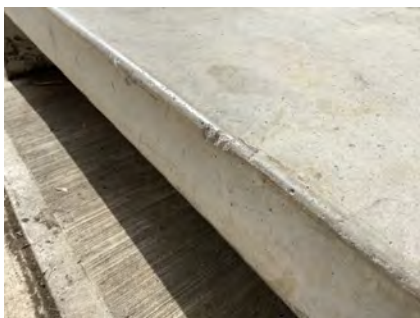
Concrete edges are in poor condition.

Risk level:
Low

Risk score:
5

Monitor edges.

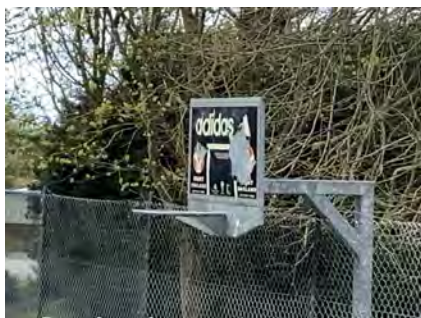
Item is damaged.

Blackboard damaged.

Medium

8

Repair.

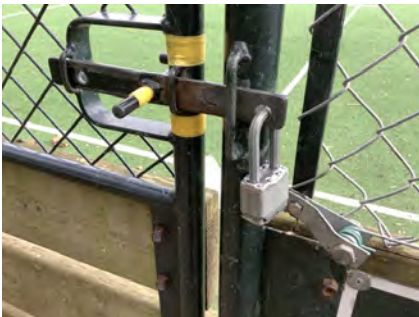
Site was locked at the time of inspection.

The MUGA gates were locked. However the perimeter was inspected.
