Safety Inspection Report

Annual Inspection

Skate Park

Manea Parish Council

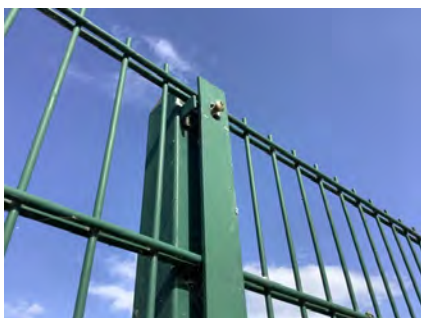
Bolt(s) loose.

Panel bolts loose.

Low

Tighten.

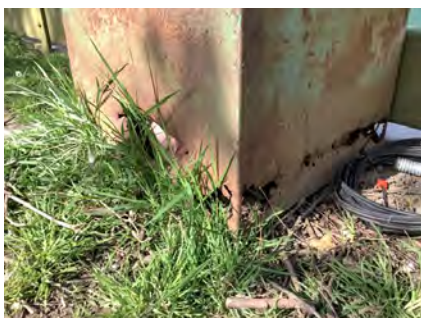
There is significant corrosion on this item.

The MUGA litter bin has rusted through leaving sharp edges.

High

Replace the item.

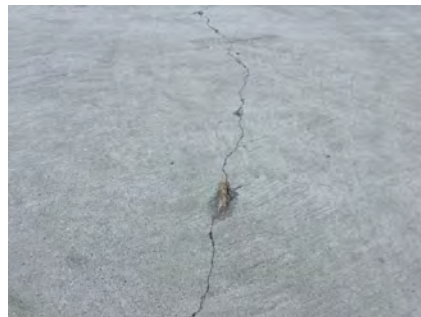
The surface is cracking.

Low

Repair.

Repair cracking.

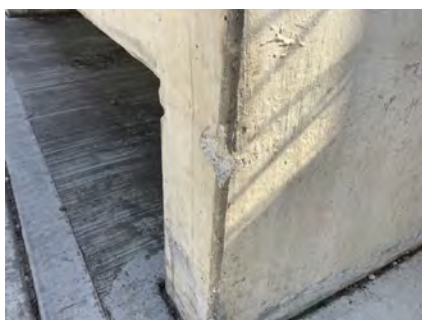
Concrete edges are in poor condition.

Low

Monitor edges.

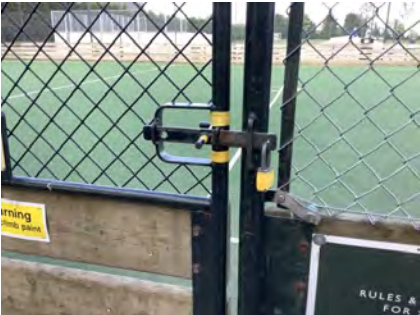
Site was locked at the time of inspection.

The MUGA gates were locked. However the perimeter was inspected.
