# Safety Inspection Report

Annual Inspection

## Park Road

Site name: **Park Road**  
Date of inspection: **20 April 2020**  
Inspector: **David Owen**

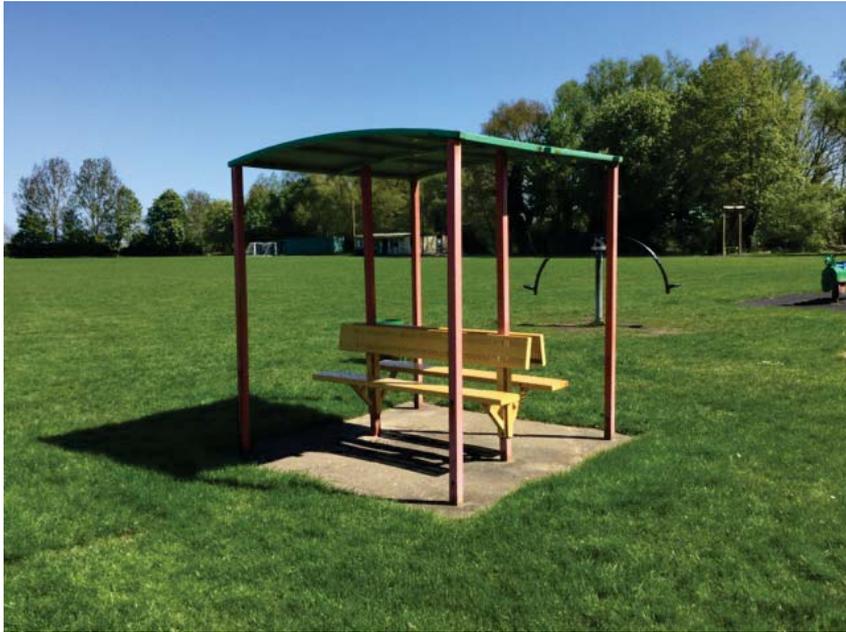
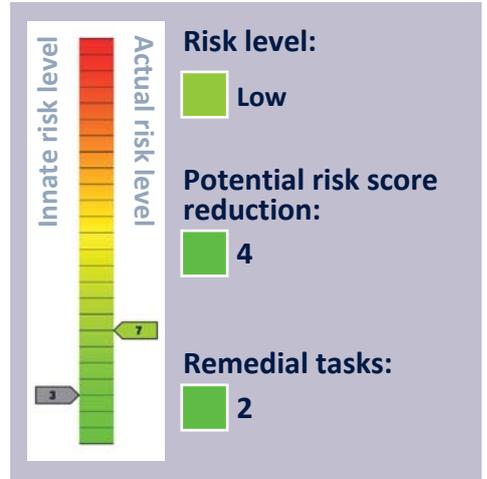
# Youth Shelter

Item has corrosion.

Read the notes for further action., Treat and repair.

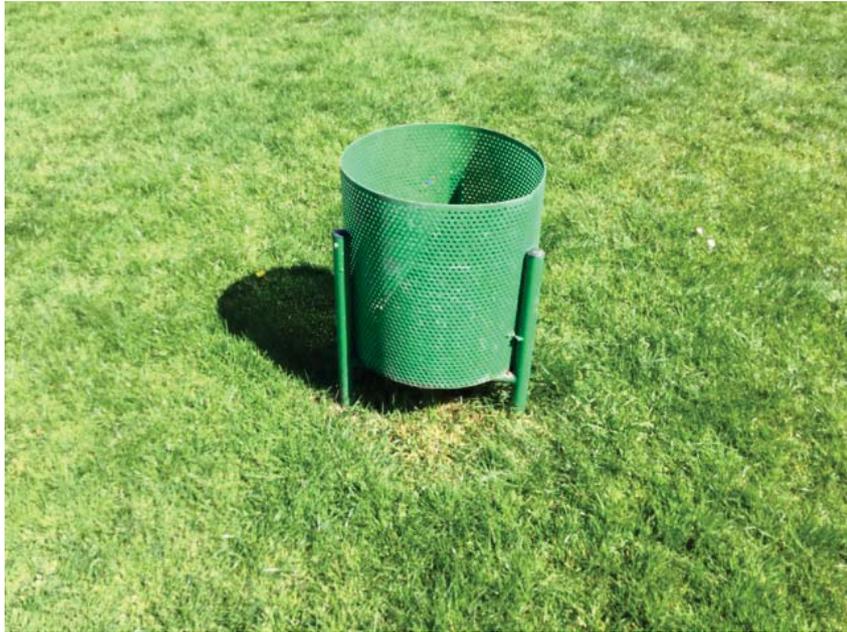
# Litter Bins

Cap missing.

Frame cap missing.

Replace.

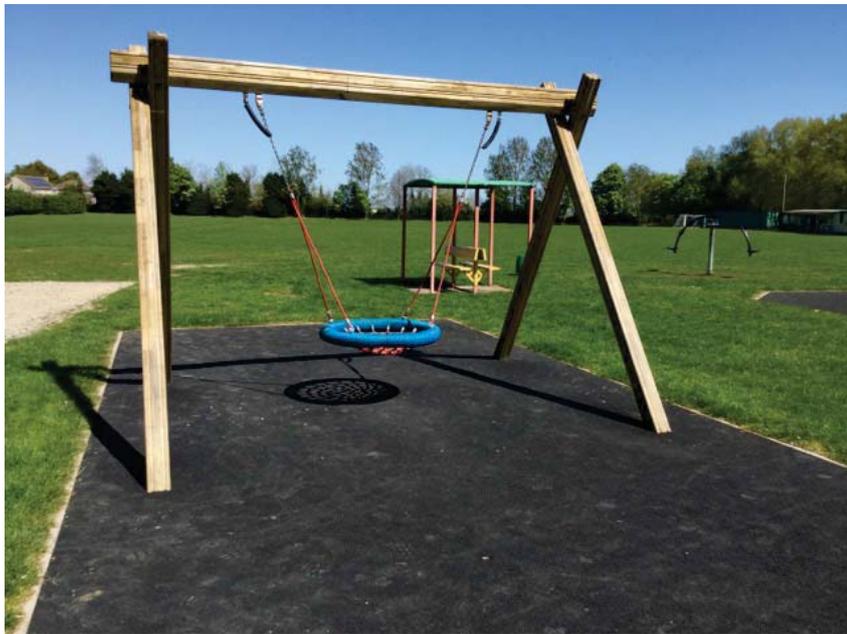
# Swing - Basket

Bolt(s) loose.

Swing hangers loose to top bar. Straighten & tighten. Failure to repair will elongate the bolt holes.

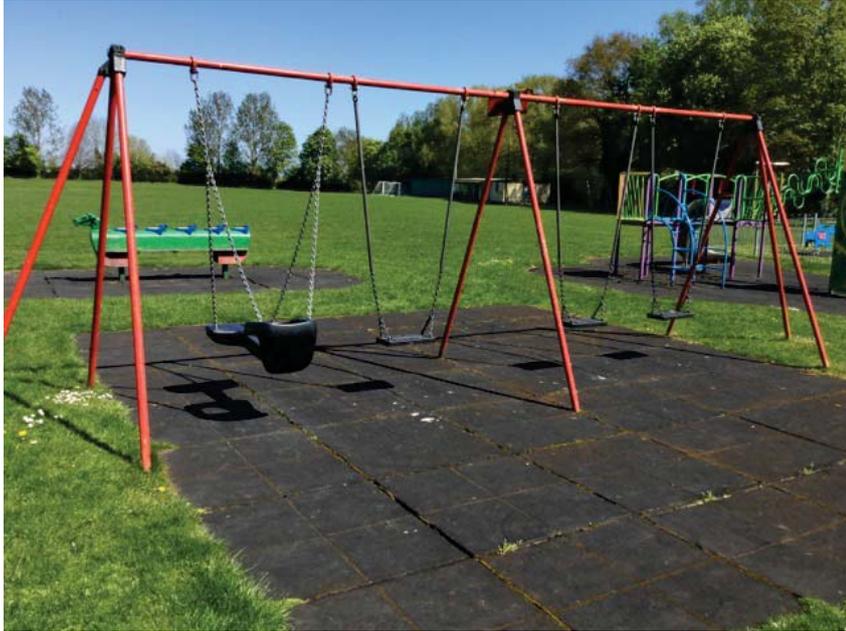
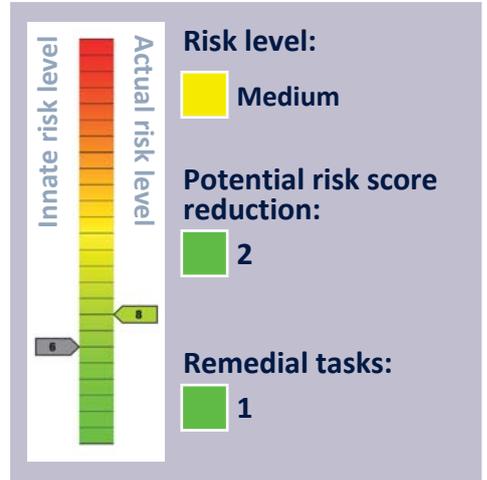
# Swing - Mixed - 2 Bay 3 Junior With Anti-Wrap 1 Tango Seat (2400 mm)

Gaps have opened up between tiles causing trip hazard.

Large gaps within the surface area could turn ankles. Gaps are larger than 30 mm where a foot could enter. This does not BS EN 1176 Part 1 Section 4.2.7.5. - repair surface.

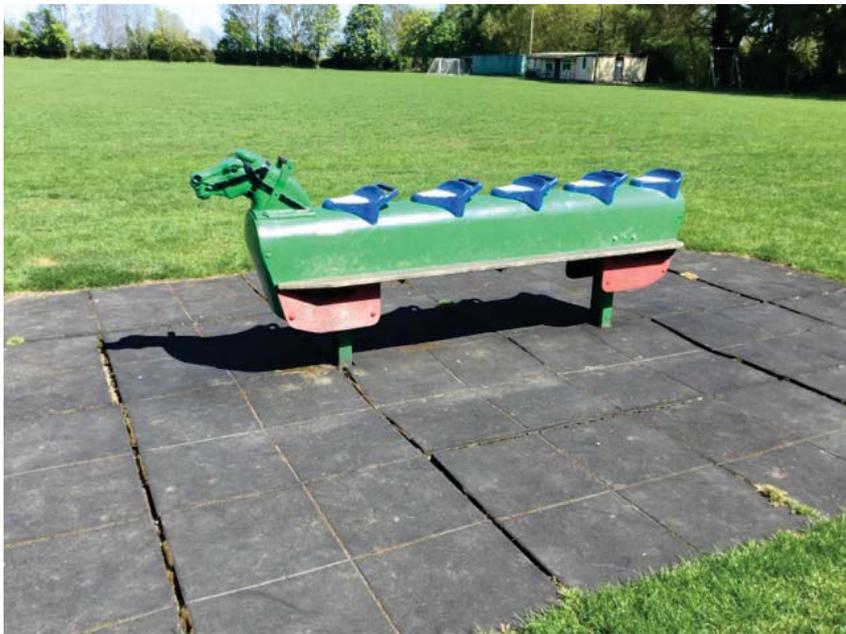
# Rocker - Rocking Horse

Gaps have opened up between tiles causing trip hazard.

Large gaps within the surface area could turn ankles. Gaps are larger than 30 mm where a foot could enter. This does not comply to BS EN 1176 Part 1 Section 4.2.7.5. - repair surface.

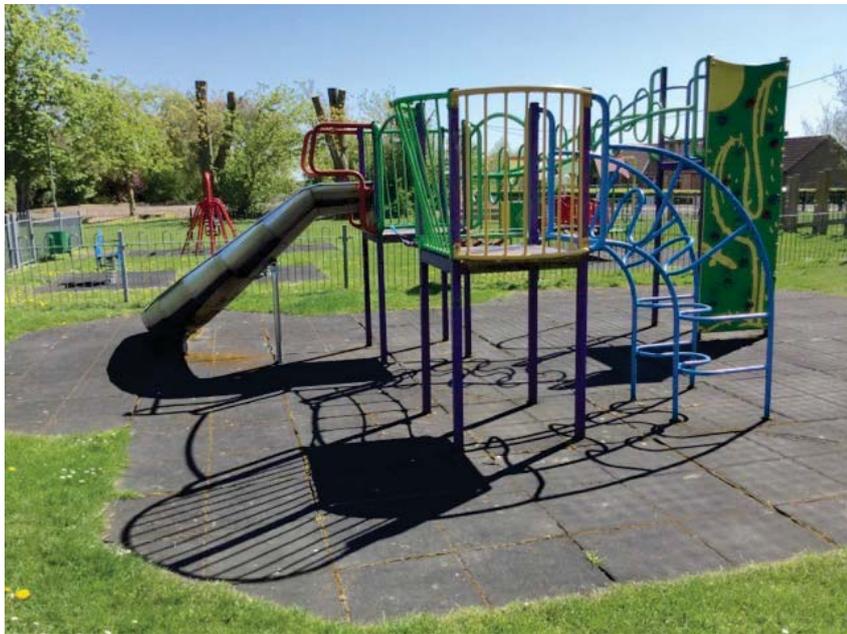
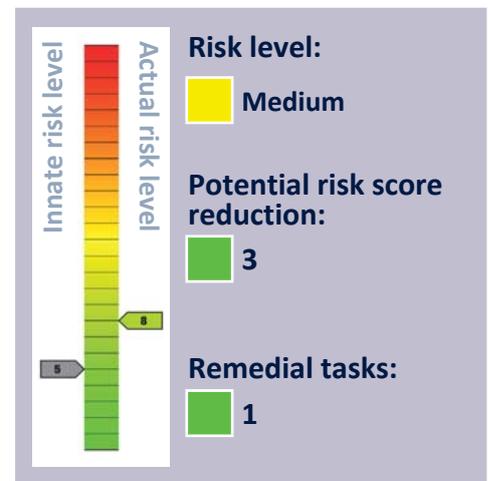
# Multiplay

Gaps have opened up between tiles causing trip hazard.

Large gaps within the surface area could turn ankles. Gaps are larger than 30 mm where a foot could enter. This does not comply to BS EN 1176 Part 1 Section 4.2.7.5. - repair surface.

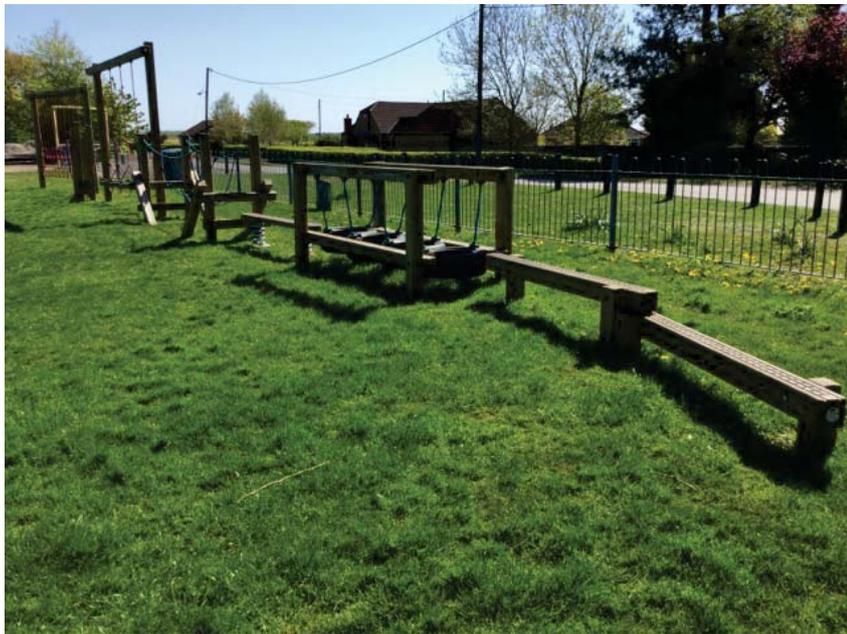
# Agility - Trim Trail

This equipment relies on one post for its stability. Special attention should be paid to maintenance (e.g. by monitoring degradation) and if necessary decommissioning the item before the end of its operating life.

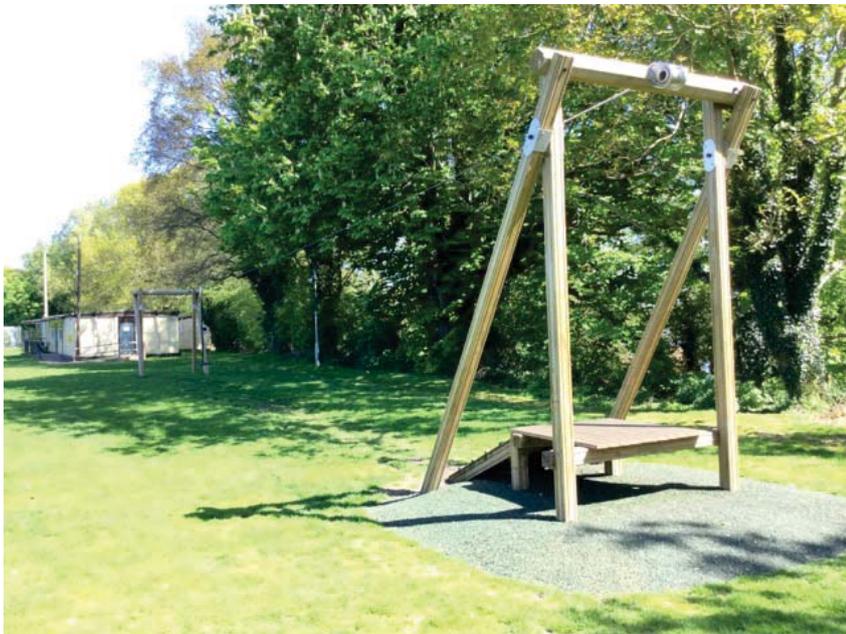
# Cableway

Fixtures loose or missing.

Three screws damaged / missing from the section support brackets.

Item is damaged.

The chain rubber sleeve is damaged at the top. The rubber will start to slip down the chain - install new bolt approximately 5" from the top to prevent ripping through the rubber.

Replace.

Repair.

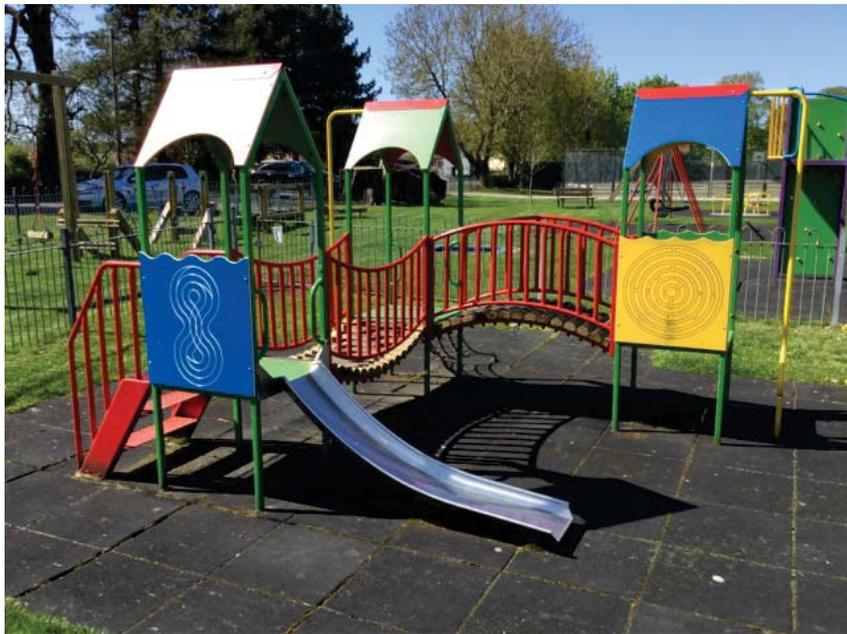
# Multiplay - Toddler - Nursery Rhymes

Cap missing.

Frame plugs missing - replace.

Gaps have opened up between tiles causing trip hazard.

Replace.

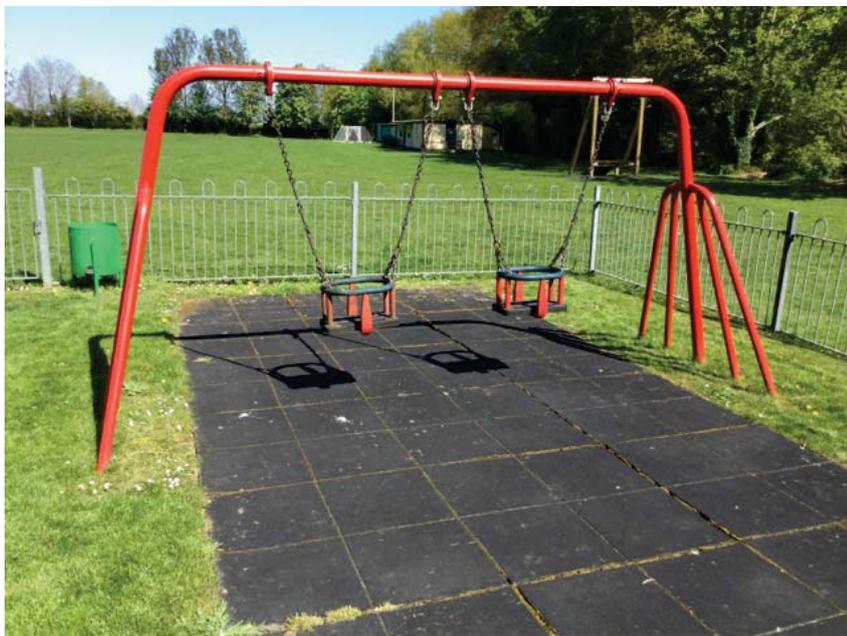
# Swing - Toddler - 1 Bay 2 Seat (1800 mm)

Gaps have opened up between tiles causing trip hazard.

Large gaps could turn ankles - repair surface, re-lay mats.

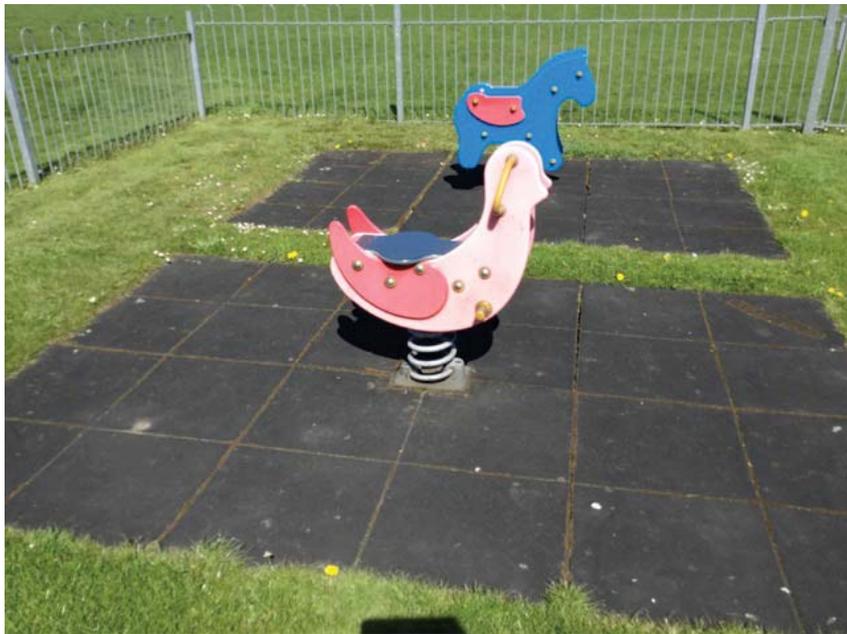
# Rocker - Bird

Gaps have opened up between tiles causing trip hazard.

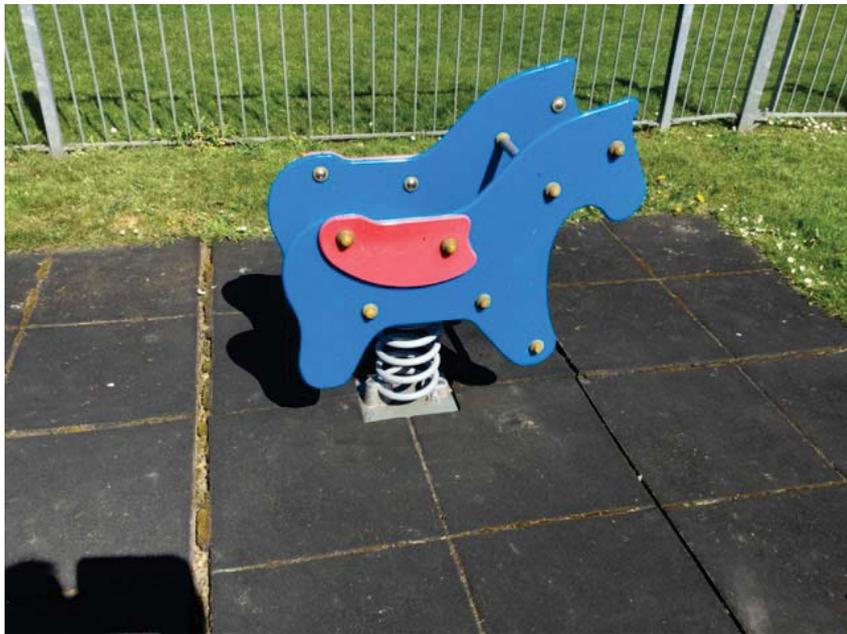
# Rocker - Horse

Gaps have opened up between tiles causing trip hazard.

Large gaps within the surface area could turn ankles. Gaps are larger than 30 mm where a foot could enter. This does not comply to BS EN 1176 Part 1 Section 4.2.7.5. - repair surface.
