# **Safety Inspection Report**

**Annual Inspection**

# **Park Road**

# Manea Parish Council

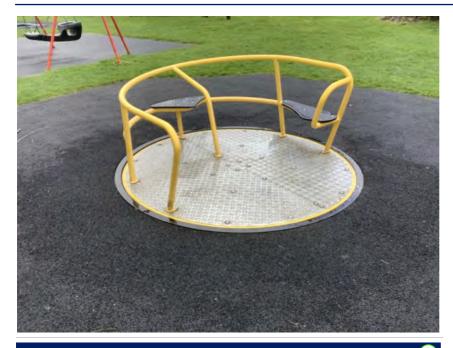
# **Carousel**

There is wear in the bushes.

Remove shackle bolt and check bush and shackle pin wear, replacing as necessary.

Replace all shackle bushes and check shackle bolts for wear.
