# Safety Inspection Report

Annual Inspection

## Park Road

Site name: **Park Road**  
Date of inspection: **12 April 2023**  
Inspector: **David Owen**

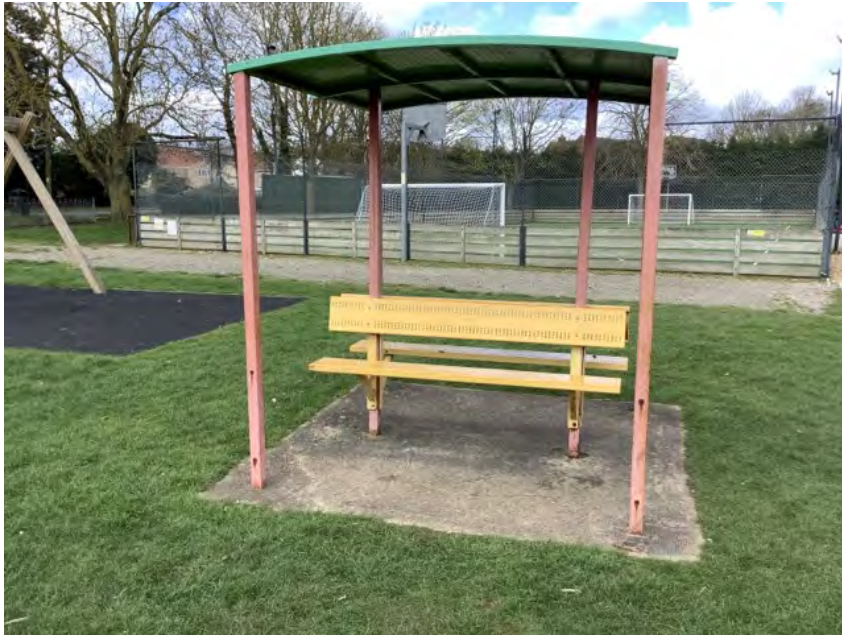
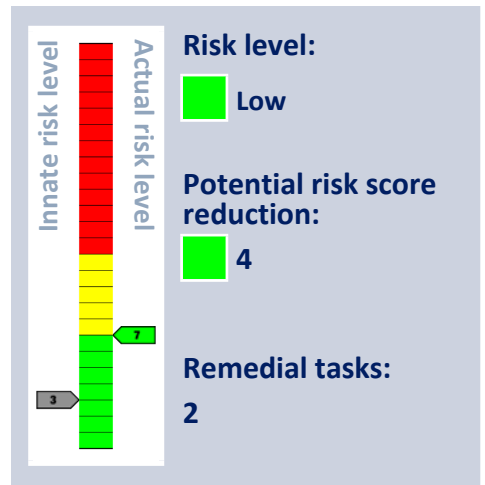
# Youth Shelter

Item has corrosion.

Read the notes for further action., Treat and repair.

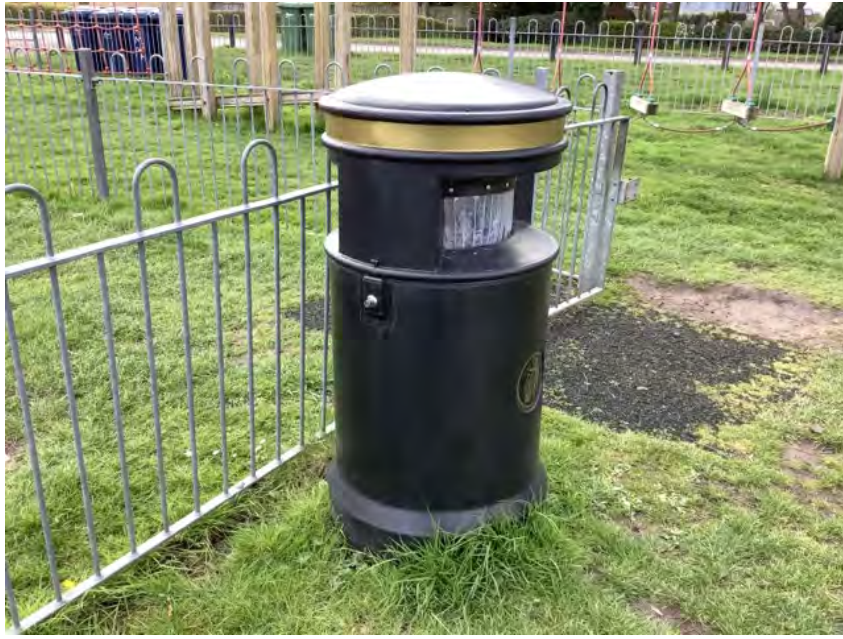
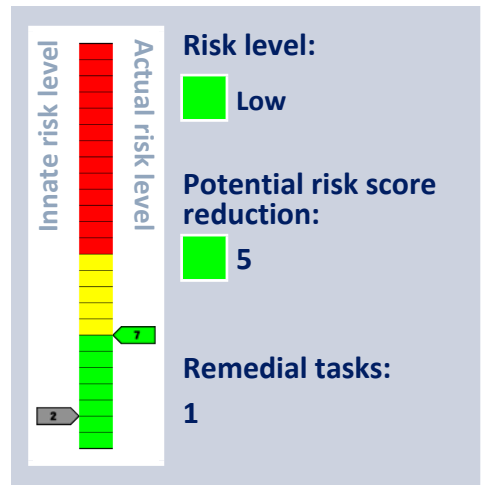
# Litter Bins

RoSPA recommends that litter bins should not be closer than 2 m from seats and gates (max of 3 m recommended). If they are too far away they may not be used. If they are too close this may cause nuisance from wasps.

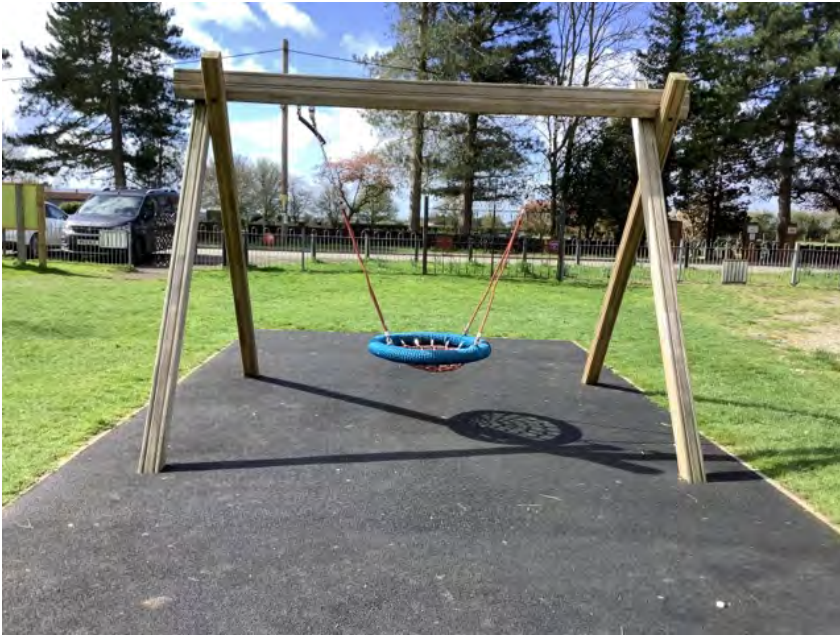
# Swing - Basket

Monitor slight wear to the surfacing.

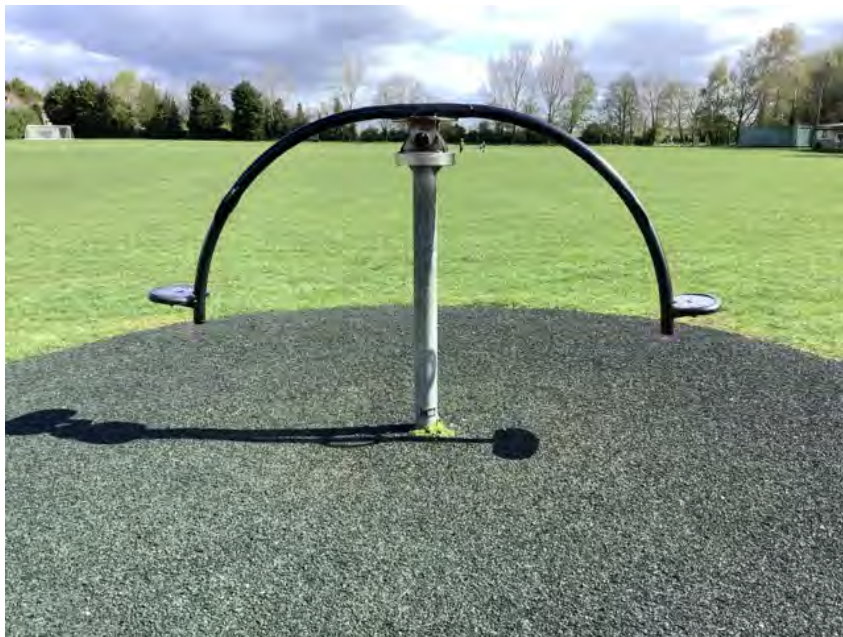
# Rocker - Sweeping Seesaw - Gyro Spiral

Fixtures loose or missing.

The top section is loose to the post, excess movement.

There is significant corrosion on this item.

De-scale back to good metal and coat with lead free paint, using appropriate precautions. Repairs may be necessary where corrosion is severe.

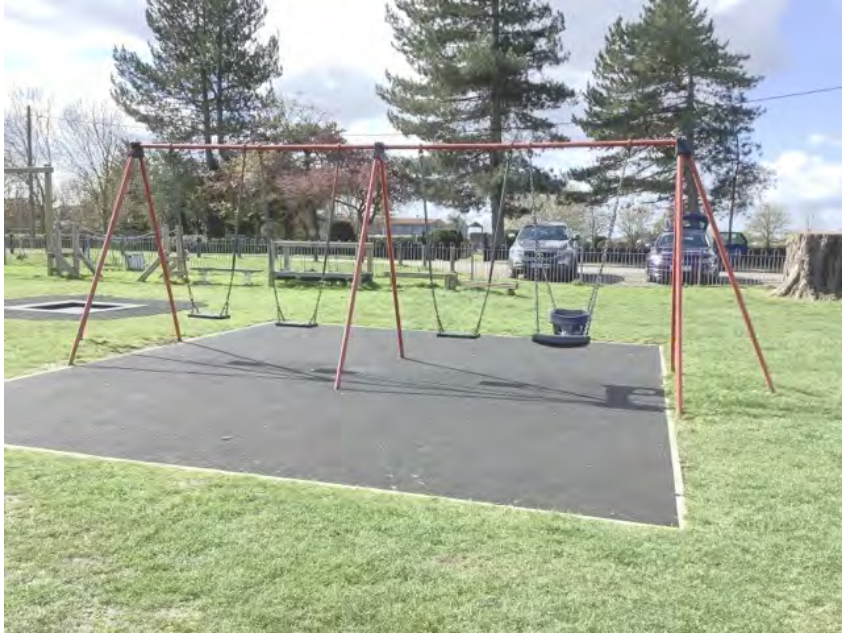
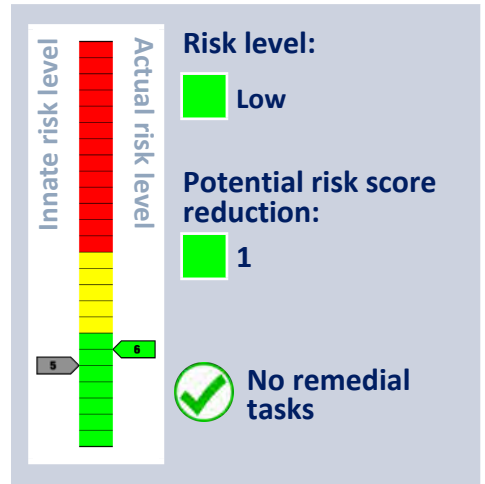
# Swing - Mixed - 2 Bay 3 Junior with Anti-Wrap 1 Tango Seat (2400 mm)

Loose swing seat eye-bolts.

Eye bolts loose on tango seat.

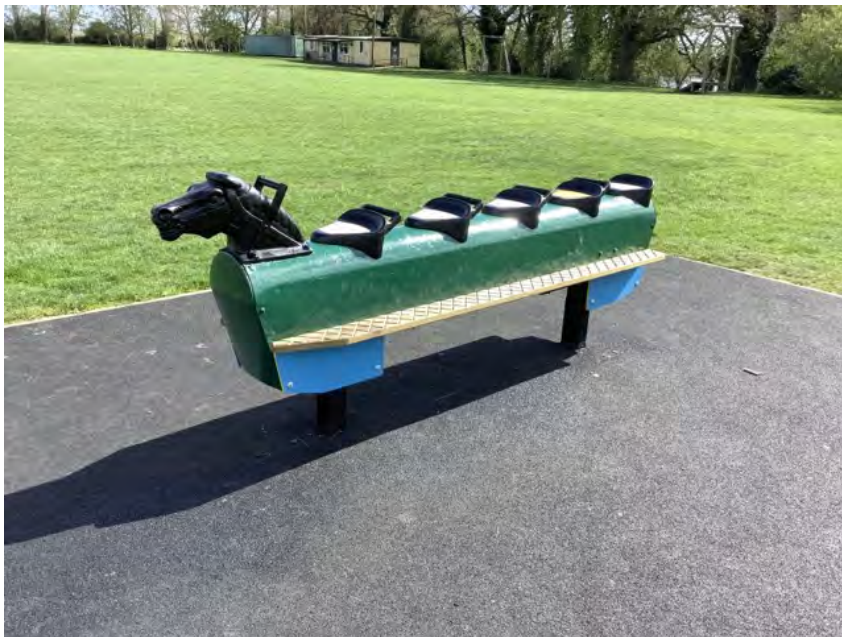
# Rocker - Rocking Horse

Front seat damaged.

Replace.

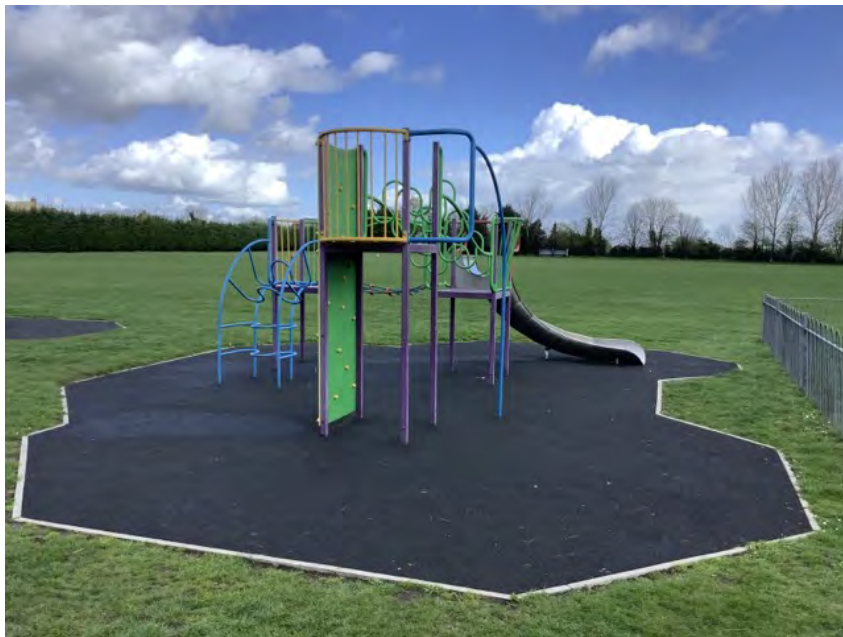
# Multiplay

The supports are loose in the ground.

Slide bottom support posts are loose in the ground.

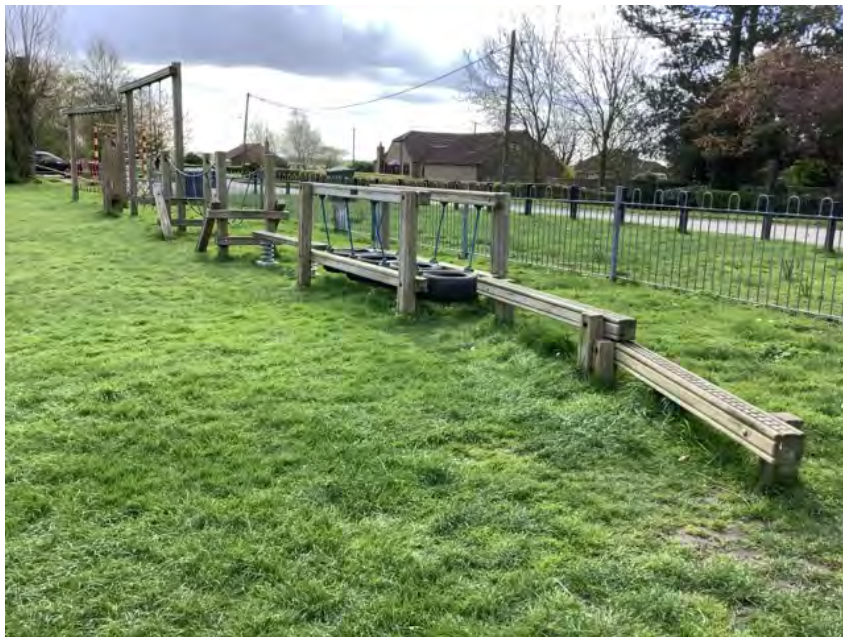
# Agility - Trim Trail

Strimmer damage to supports is likely to accelerate timber rot.

Timber is decayed.

Large net traverse climber has a decayed end post. The post made a cracking sound at ground level while undergoing the whip test. Replace as soon as possible.

Prevent further damage.

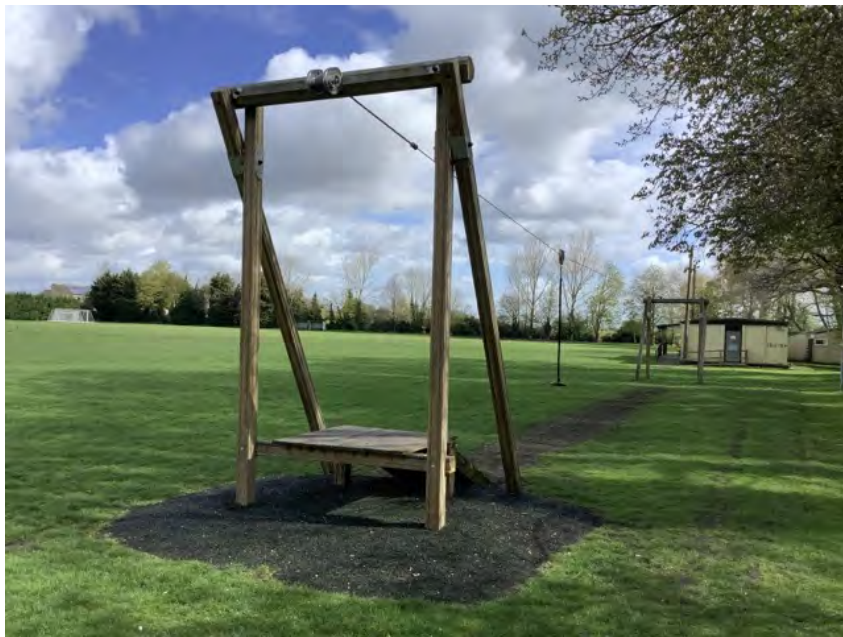
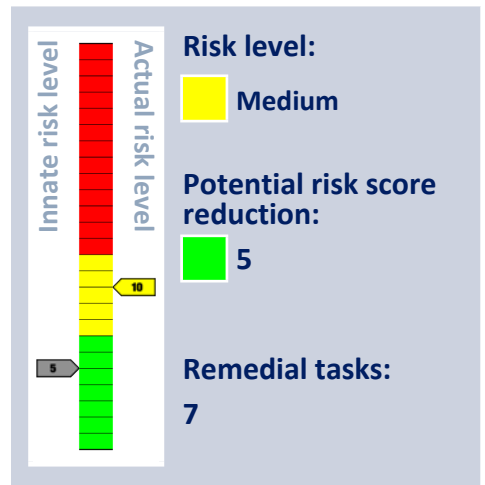
# Cableway

Bolt(s) missing.

Bolts missing from the support leg bracket.

Item broken.

Spring stop broken.

Item is damaged.

The chain rubber sleeve is damaged at the top. The rubber has now slipped down the chain creating a pinch point. Repair and Install new bolt approximately 5" from the top to prevent ripping through the rubber.

Item is worn.

Traveler plastic cable guard worn.

Strimmer damage to supports is likely to accelerate timber rot.

End angle post damaged, possibly by the gang mower.

Replace.

Repair.

Prevent further damage.

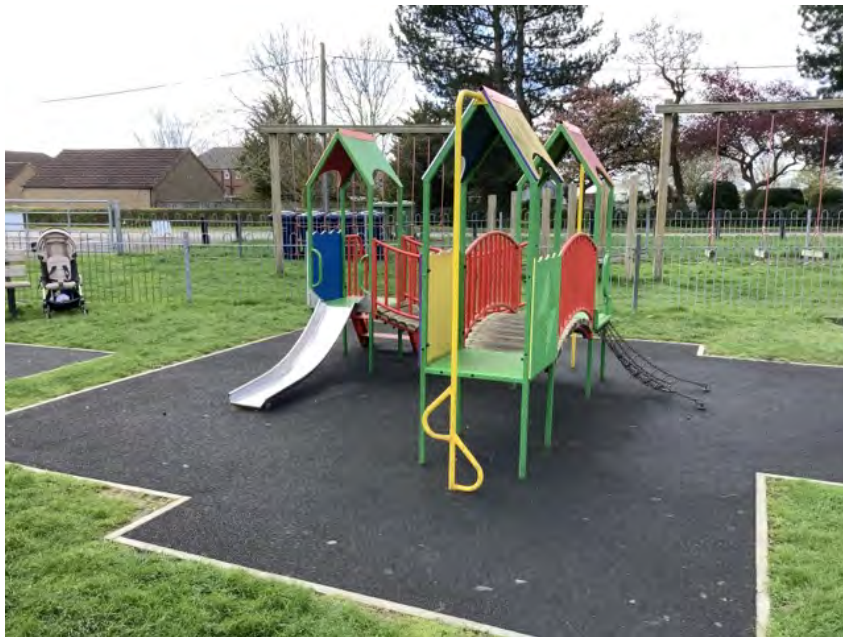
# Multiplay - Toddler - Nursery Rhymes

Cap missing.

Frame plugs missing. Replace.

Replace.
