Safety Inspection Report

Annual Inspection

Skate Park

Manea Parish Council

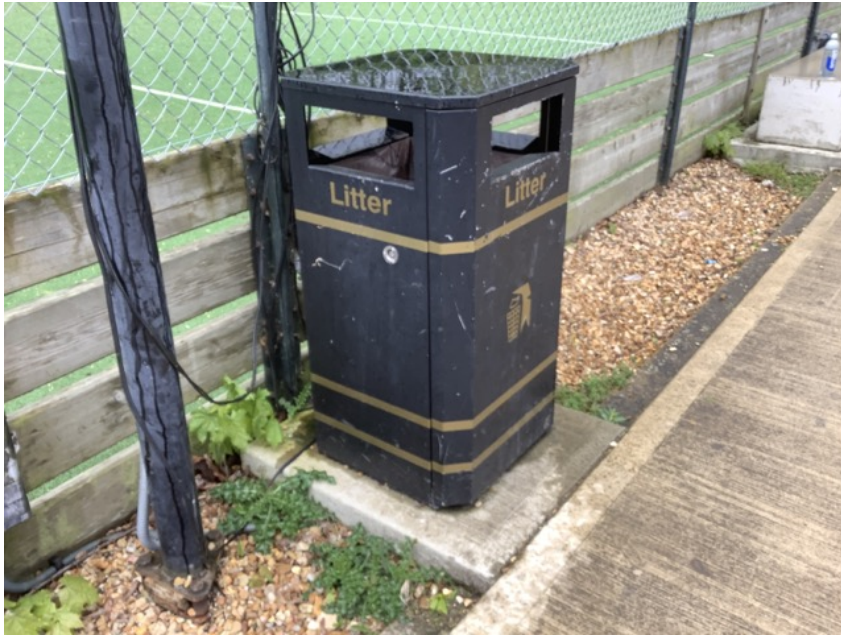
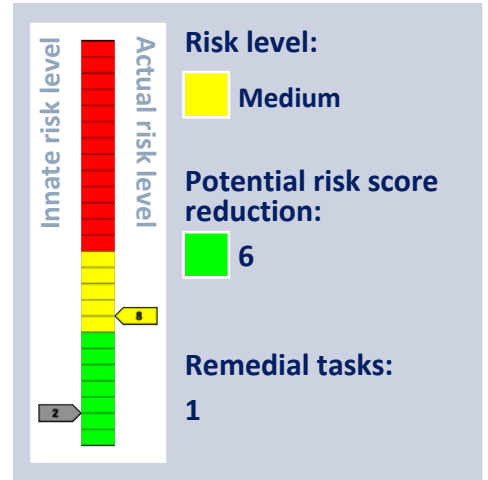
Litter Bins

Item has corrosion.

Litter bin adjacent to the MUGA picnic table has corroded through leaving sharp edges. Remove.

Replace.

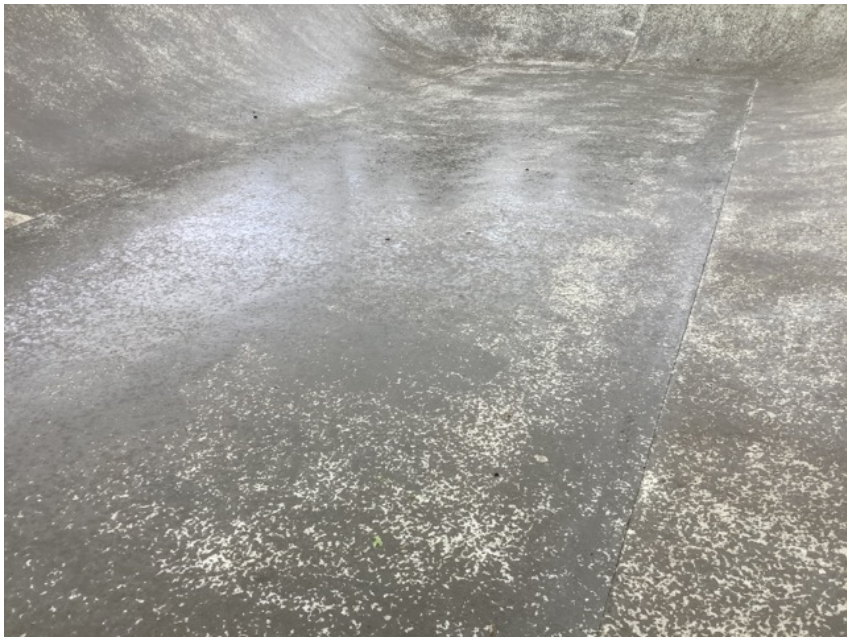
General Surface - Concrete

Description
The surface is cracking.
Tasks
Repair.
Note
Small section cracking repair and monitor all repaired sections.

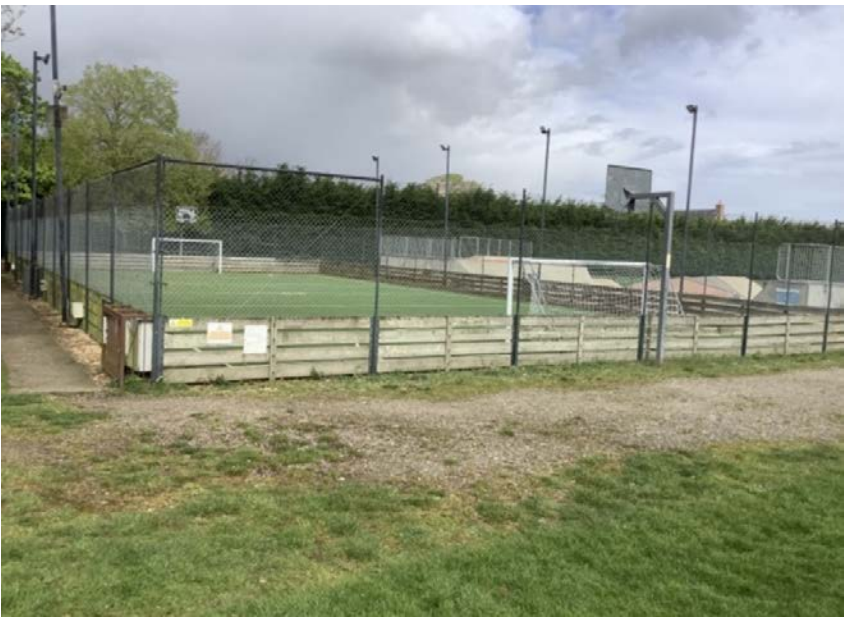
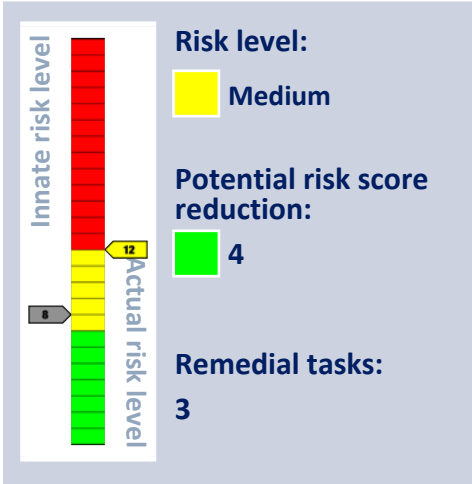
MUGA

Item is damaged.

Blackboard damaged.

Repair.
