# **Safety Inspection Report**

**Annual Inspection**

# Park Road

Manea Parish Council

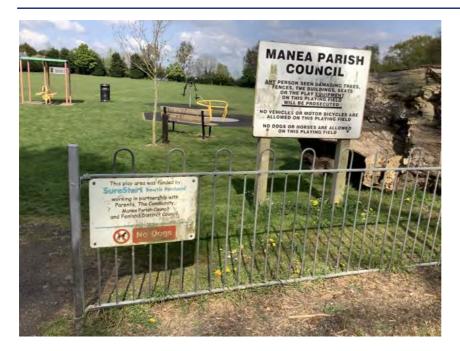
# Signage - Info

Sharp edges to frame of signage - Smooth off.

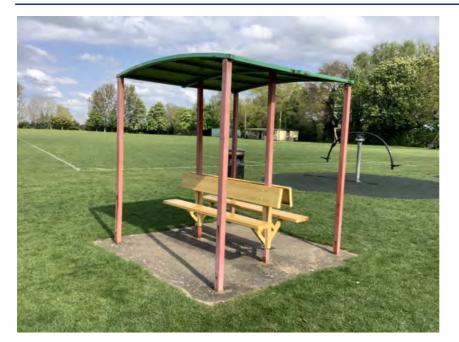
# **Youth Shelter**

Description	Risk level:
Item has corrosion.	Low
Tasks	
Read the notes for further action., Treat and repair.	Risk score:
Note	· · · · · · · · · · · · · · · · · · ·

The frame seam is splitting open. This may be due to water ingress.

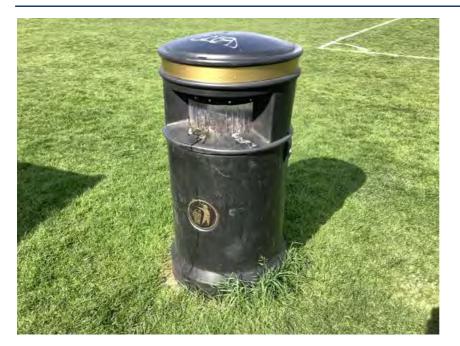
# **Litter Bins**

RoSPA recommends that litter bins should not be closer than 2 m from seats and gates (max of 3 m recommended). If they are too far away they may not be used. If they are too close this may cause nuisance from wasps.

Due to wasps and bees.

Move the bin or seat as appropriate.

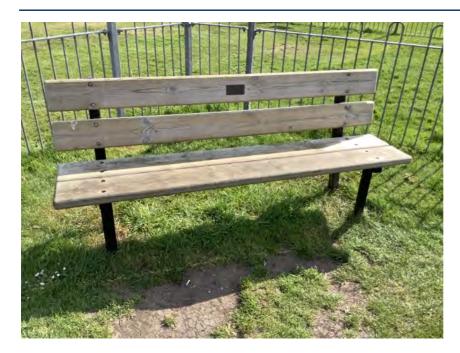
# **Seating - Various**

Description	Risk level:
Ground erosion present.	Low
Tasks	
Repair the worn areas.	Risk score:
Note

In front of the toddler seat.

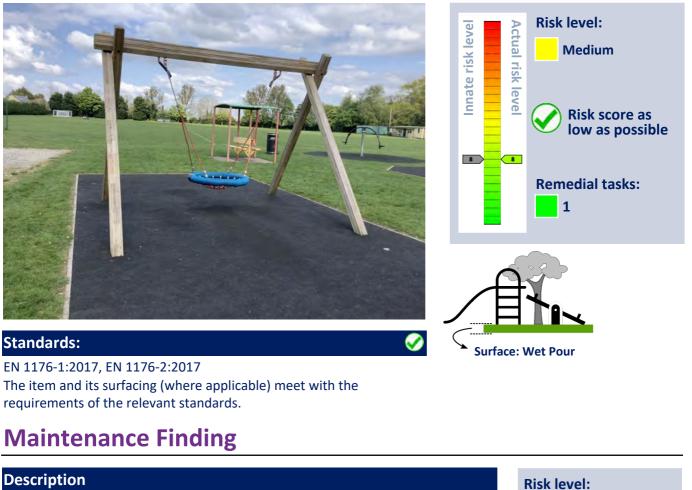
# **Swing - Basket**

Bolt(s) loose.

Swing hanger x 1 loose to top bar. Straighten & tighten. Failure to repair will elongate the bolt holes.

Tighten.

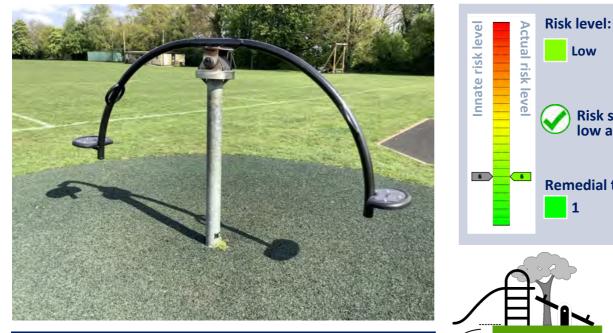
# **Rocker - Sweeping Seesaw - Gyro Spiral**

There is significant corrosion on this item.

De-scale back to good metal and coat with lead free paint, using appropriate precautions. Repairs may be necessary where corrosion is severe.

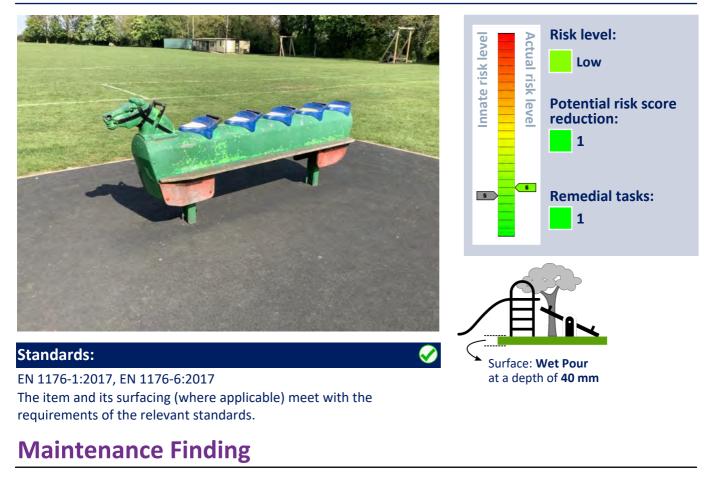
# **Rocker - Rocking Horse**

Front seat damaged.

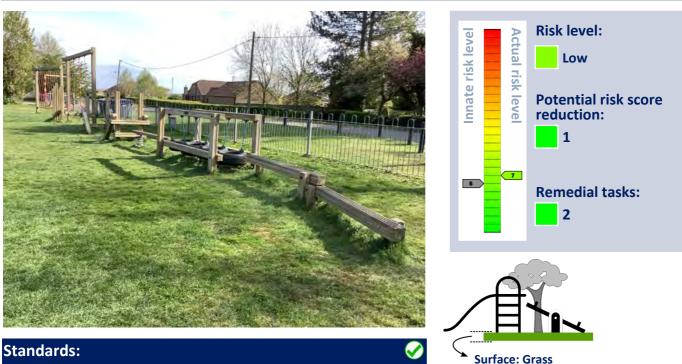
# **Agility - Trim Trail**

There is excess movement to the tyre walk to the front and rear of the unit - Consult the manufacturer for their comments.

Read the notes for further action.

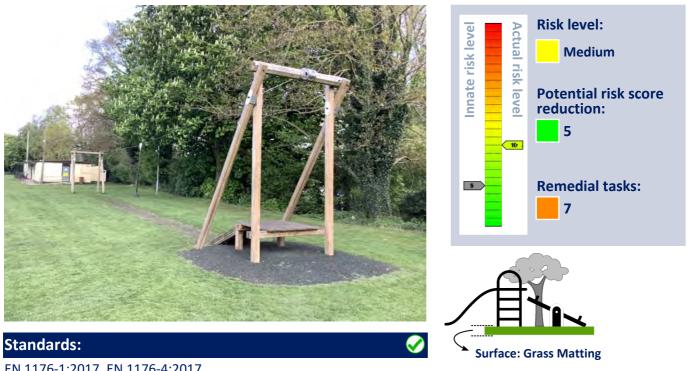
# Cableway

Cables have been known to fail under load due to wear and corrosion. This is generally where the cable enters into a tube, top bar or similar, where the wire is in contact and wears and frays over time. Damaged cables require replacement. This cannot be determined during an annual inspection, and is excluded from our inspection. This finding is generically high risk and action is required. Refer to the manufacturer's instructions to ensure the correct check is carried out.

Three screws damaged/missing from the section support brackets (1 x starting section & 2 x terminal section.

Spring stop broken.

The chain rubber sleeve is damaged at the top. The rubber will start to slip down the chain - Install new bolt approximately 5" from the top to prevent ripping through the rubber.

Traveler plastic cable guard worn.

Description	Risk level:
Strimmer damage to supports is likely to accelerate timber rot.	Low
Tasks	
Prevent further damage.	Risk score:

End angle post damaged, possibly bu he gang mower.

Conduct an appropriate dismantling inspection.

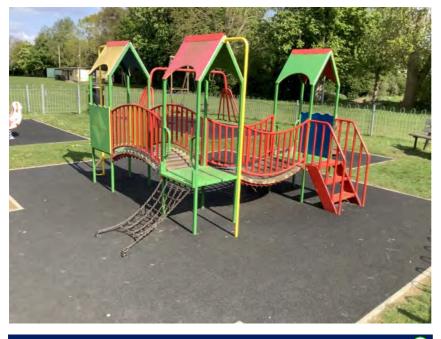
# **Multiplay - Toddler - Nursery Rhymes**

Frame plugs missing - Replace.

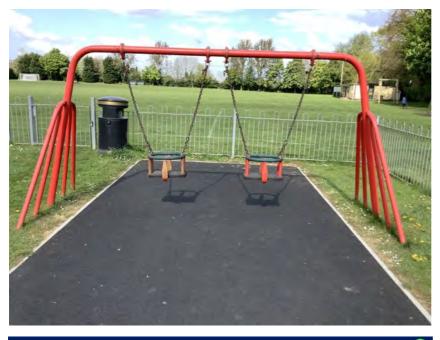
# Swing - Toddler - 1 Bay 2 Seat (1800 mm)

Swing shackles have been over-tightened causing them to jam.

Shackle bolts do not rotate within the bushes x 4.

Risk level: Medium Risk score: 9

Apply lubricant according to the manufacturer's instrutions.
