Safety Inspection Report

Annual Inspection

Park Road

Manea Parish Council

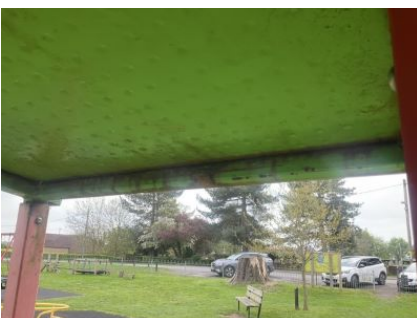
Litter Bins

RoSPA recommends that litter bins should not be closer than 2 m from seats and gates (max of 3 m recommended). If they are too far away they may not be used. If they are too close this may cause nuisance from wasps.

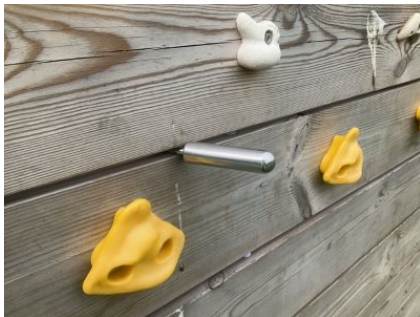
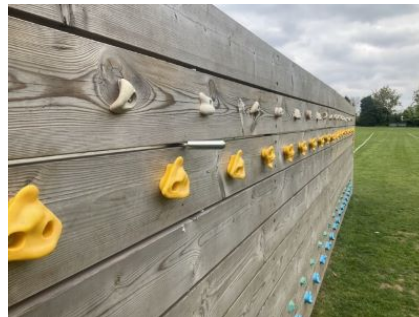
1. Fixtures loose or missing.

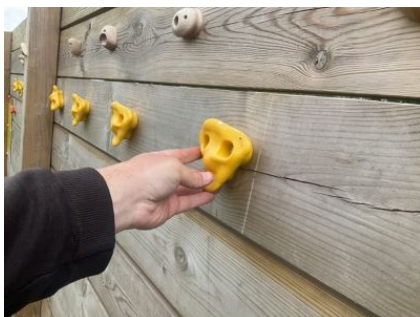
Fixtures loose or missing.

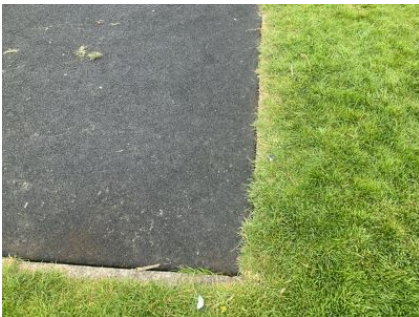
Shrinkage / separation of the surface. This may give a trip hazard.

Edges are shrinking and lifting creating trip points/ ankle turns. Repair.

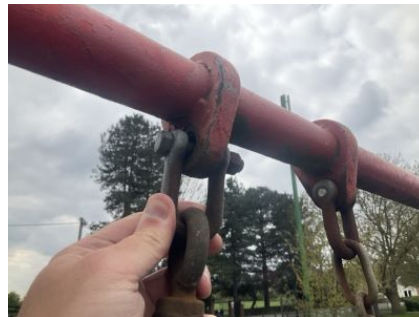
Loose swing seat eye-bolts.

Eye bolts loose on tango seat.

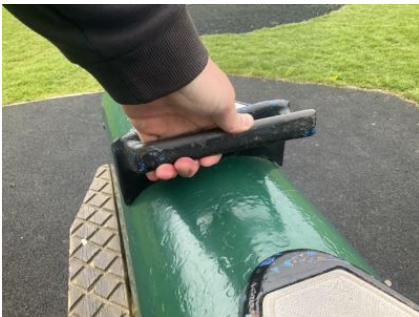
Front seat damaged.

Bolt(s) loose.

Replace.

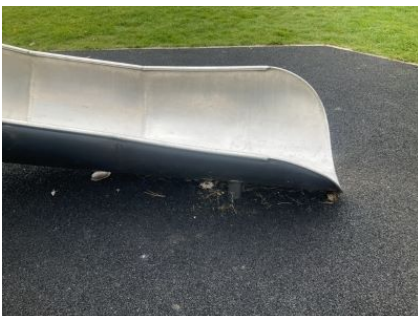
The supports are loose in the ground.

Slide bottom support posts are loose in the ground.

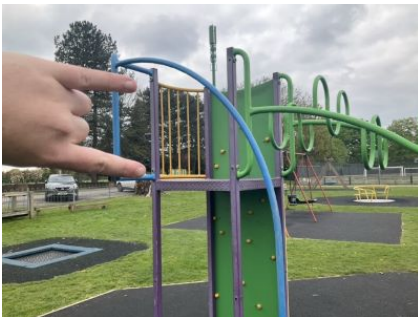
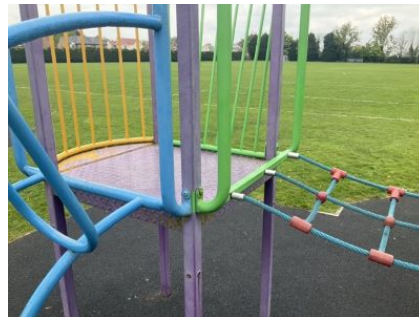
Bolt(s) loose.

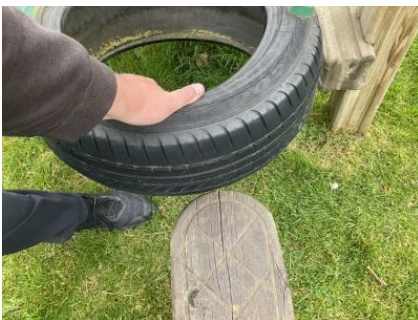
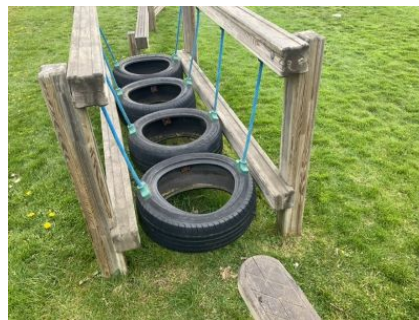
Strimmer damage is present on posts, allowing water to enter and timbers to soften. It can also remove the protective envelope around the timber. Prevent further damage and check timbers for decay throughout the year.

Prevent further damage.

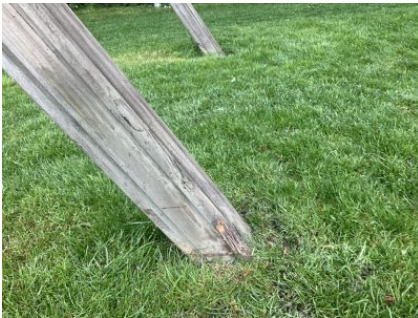
Multiple end supports are damaged, possibly by the gang mower.

Repair.

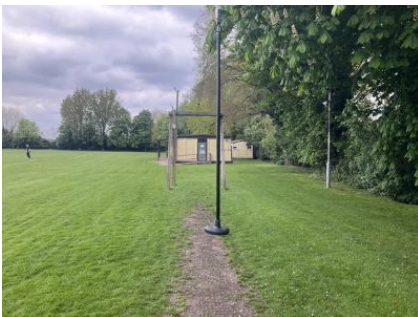
Remove chain covers to inspect according to manufacturer's instructions, and replace the covers when done.

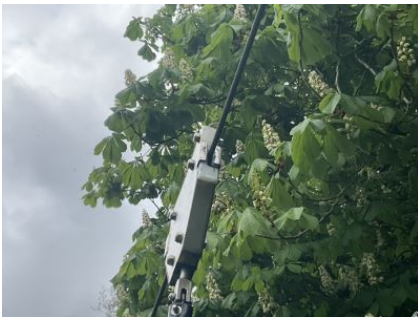
Item is worn.

Finger guards nearly worn through on traveller.

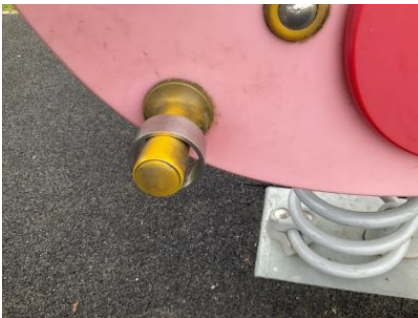
Cap missing.

Replace.
