# Safety Inspection Report

Annual Inspection

## Park Road

Manea Parish Council

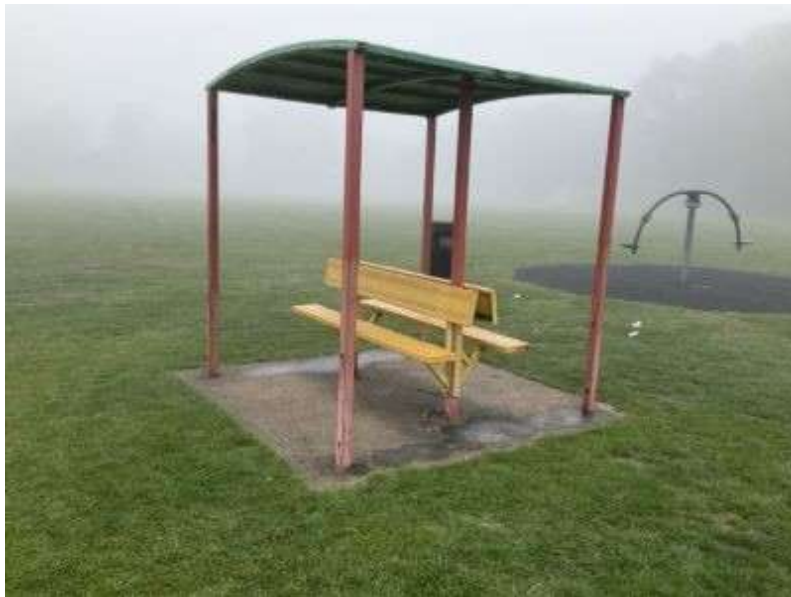
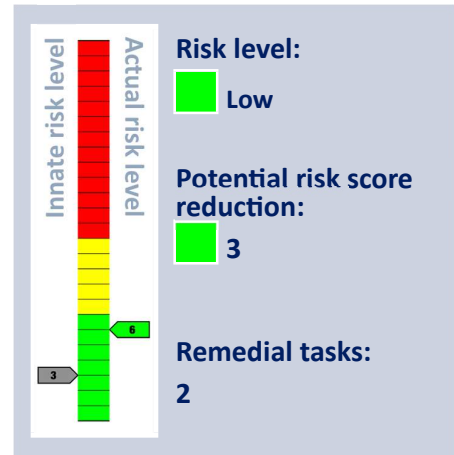
# Youth Shelter

corrosion.

Read the notes for further action., Treat and repair.

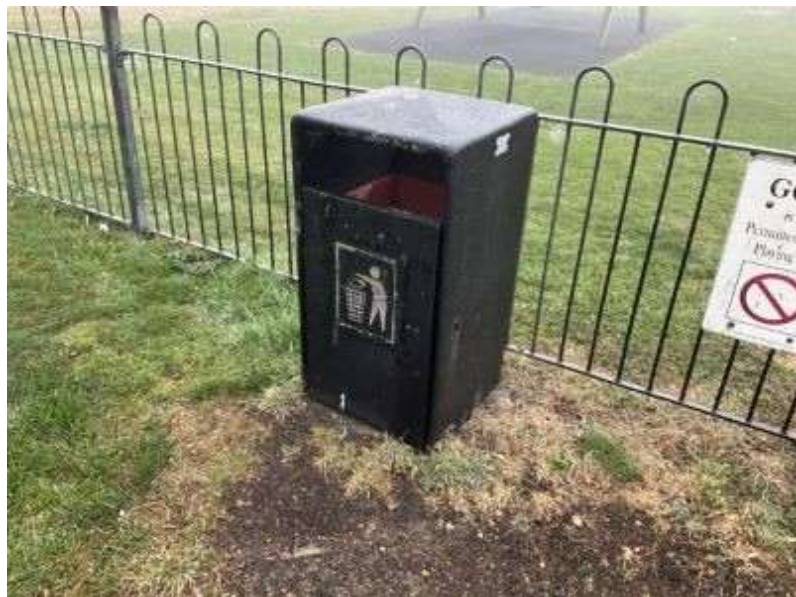
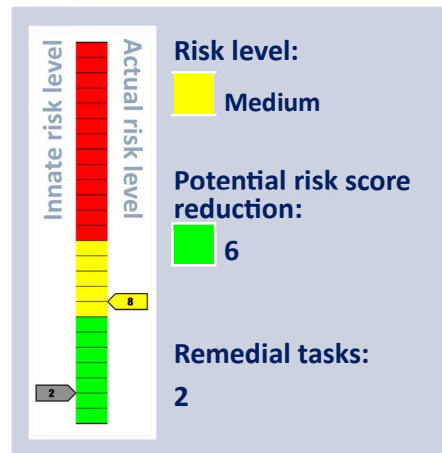
# Litter Bins

supports are loose in the ground.

Toddler bin loose in the ground exposing the foundations.

RoSPA recommends that litter bins should not be closer than 2 m from seats and gates (max of 3 m recommended). If they are too far away they may not be used. If they are too

cause nuisance from wasps.

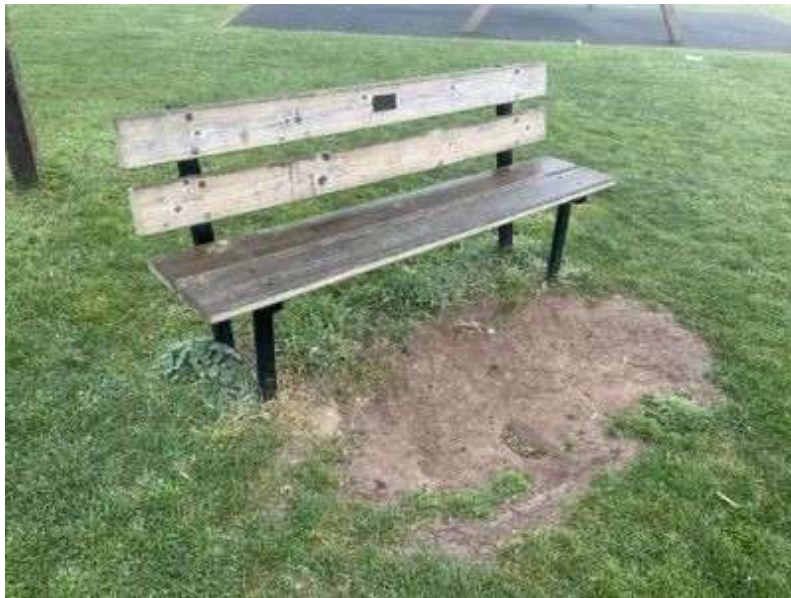
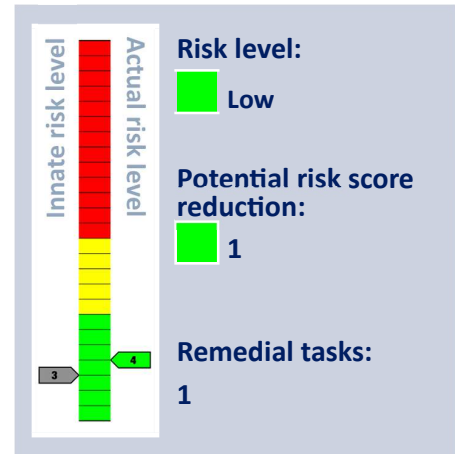
# Seating - Various

In front of the toddler seat.

Repair the worn

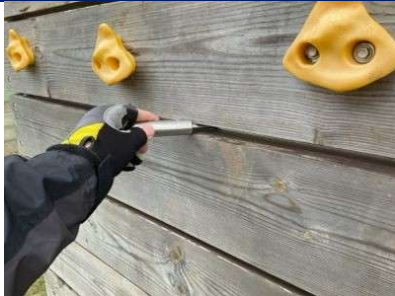
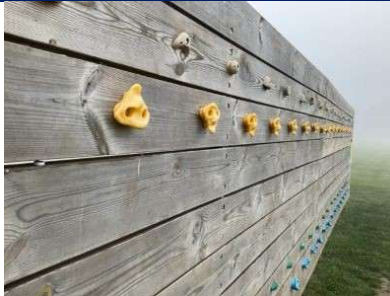
There are finger entrapments between the boards.

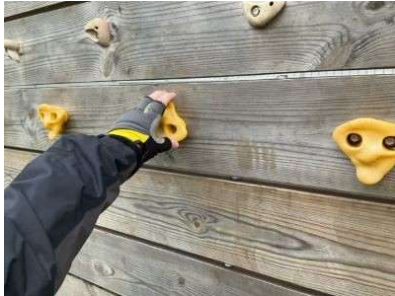
Fixtures loose or missing.

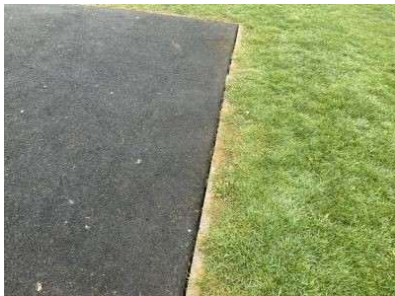
Shrinkage / separation of the surface. This may give a trip hazard.

Edges are shrinking and lifting creating trip points/ankle turns. Repair.

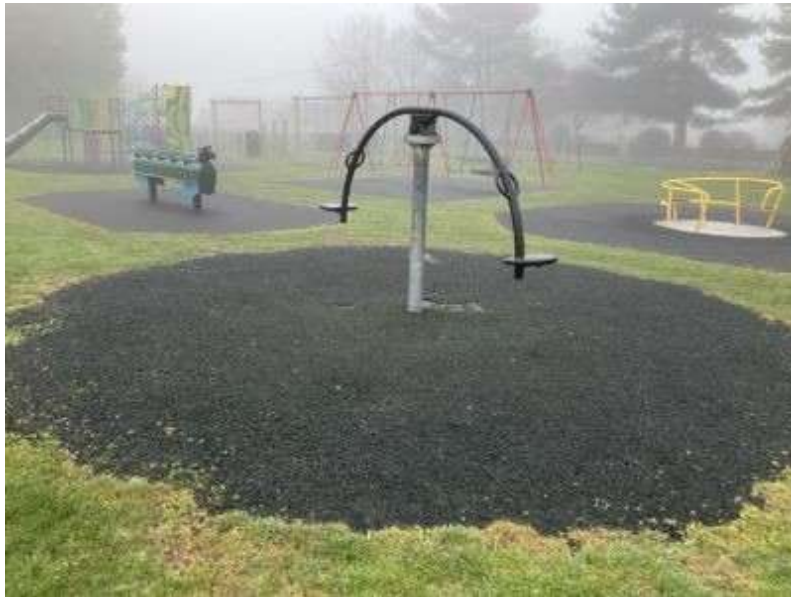
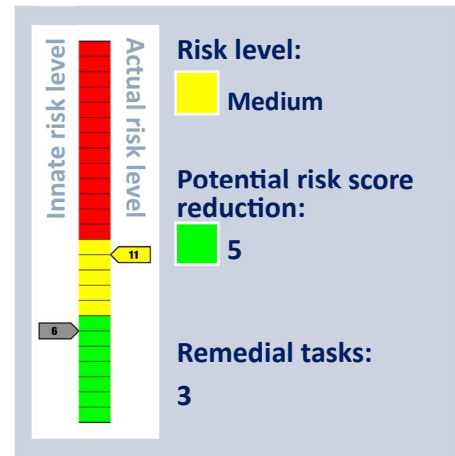
# Rocker - Sweeping Seesaw - Gyro Spiral

The top section is loose to the post, excess movement and worn bearings.  
Dismantle and secure/replace affected fittings.

Surface needs repair.

Repair.

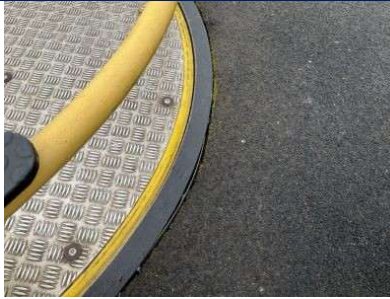
Shrinkage / separation of the surface. This may give a trip hazard.

are shrinking and lifting creating trip points/ankle turns. Repair.

Edges

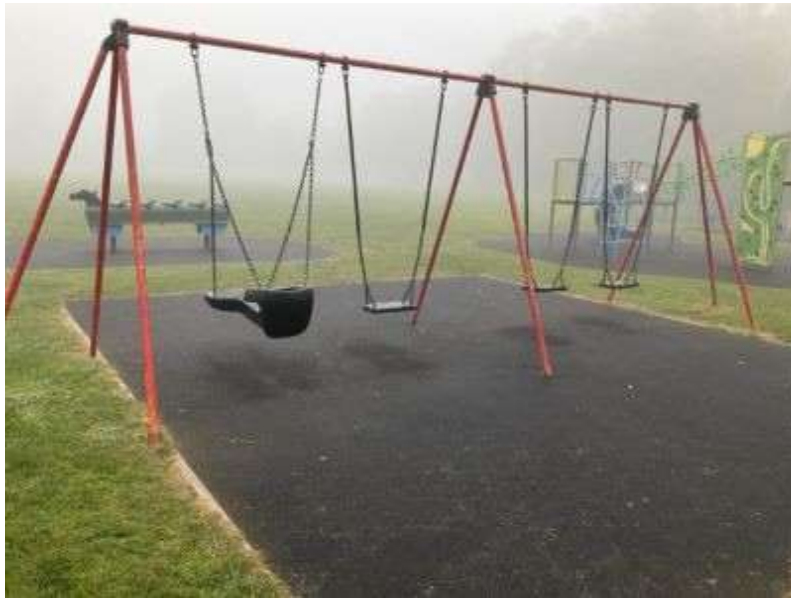
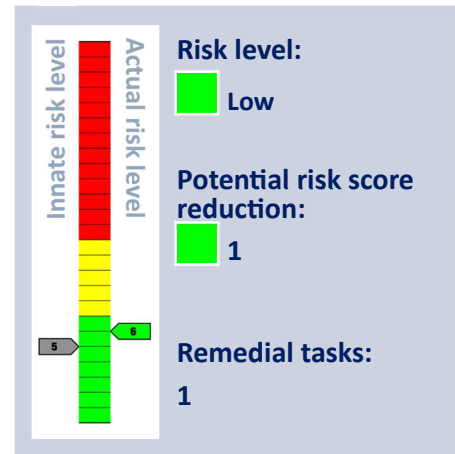
# Swing - Mixed - 2 Bay 3 Junior - With Anti-Wrap 1 Tango Seat (2400 mm)

Loose swing seat eye-bolts.

bolts loose on tango seat.

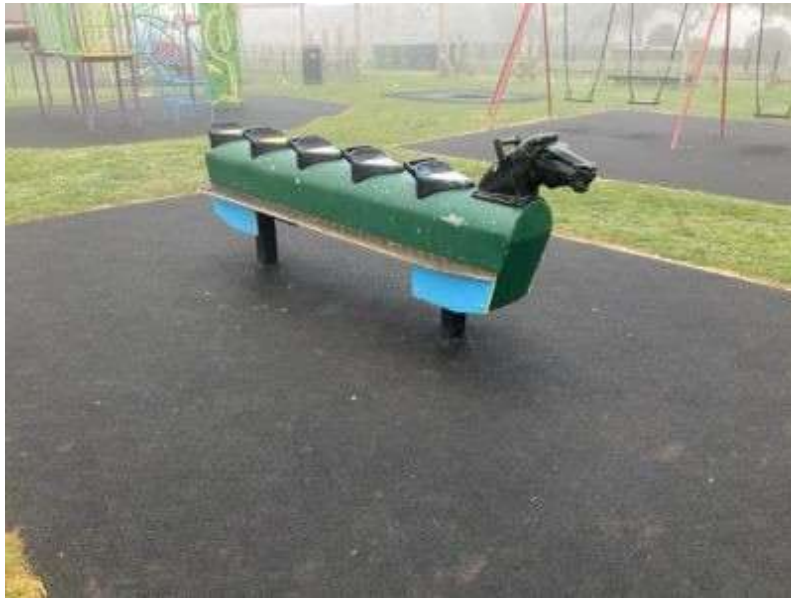
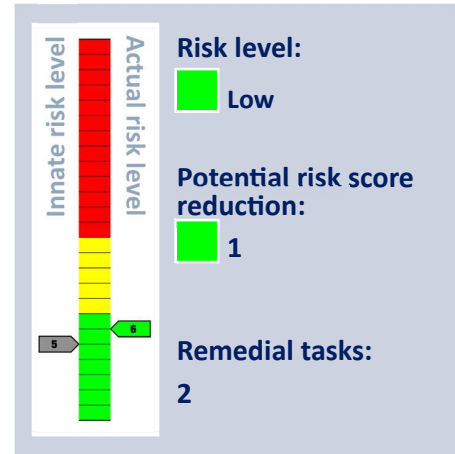
# Rocker - Rocking Horse

seat damaged.

Bolt(s) loose.

Replace.

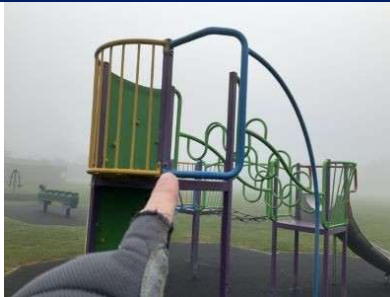
Bolt(s) loose.

Descending pole bolts and barrier bolts around bridge.

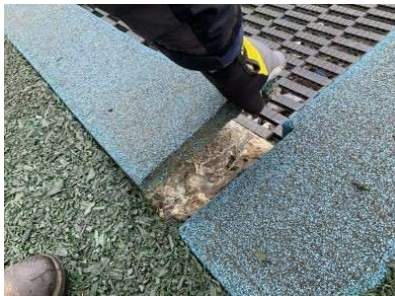
Lifting rubber padding.

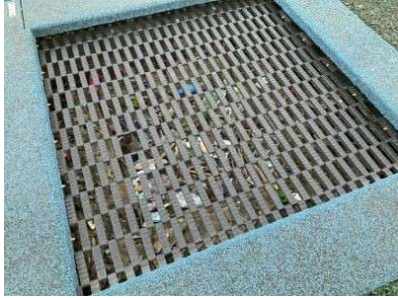
Item is damaged.

Trampoline bed damaged.

Repair.

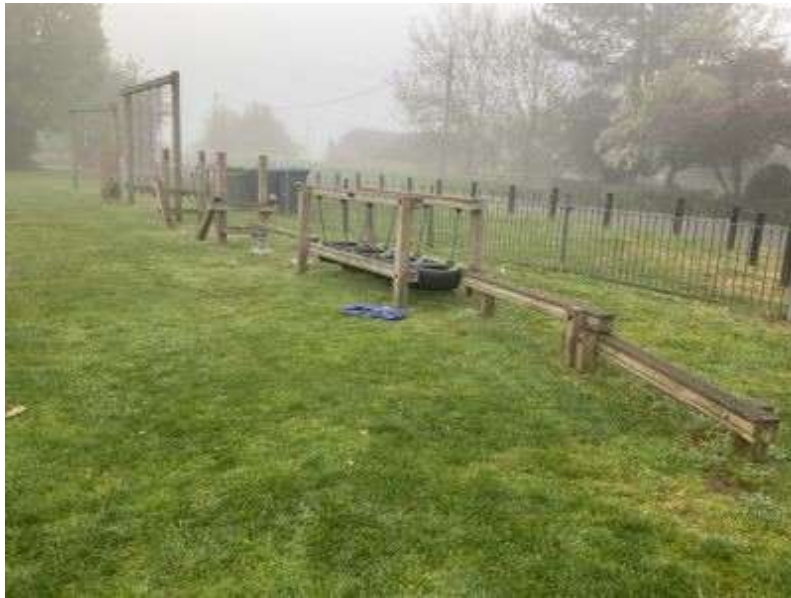
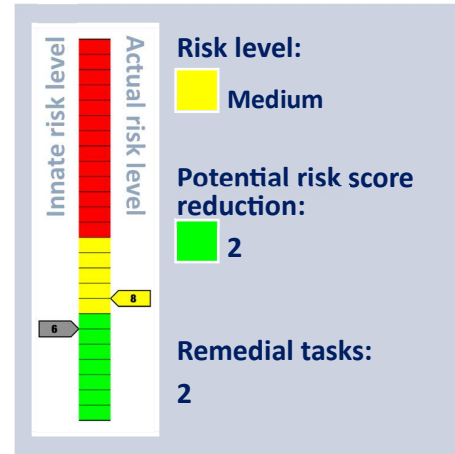
# Agility - Trim Trail - 7 stations

Strimmer damage is present on posts, allowing water to enter and timbers to soften. It can also remove the protective envelope around the timber. Prevent further damage and check timbers for decay throughout the year.

Multiple end supports are damaged, possibly by the gang mower.

Prevent further damage.

Repair.
